Sealing the cap rail joint on Westsails

[Westsail #91 S/V Resolve](#) Jim Harrison
[Westsail #207 S/V Tortuga](#) -Randy Leasure
[Westsail # 567 S/V Pygmalion](#) – Jay Bietz

By Jay Bietz
6/2/2022

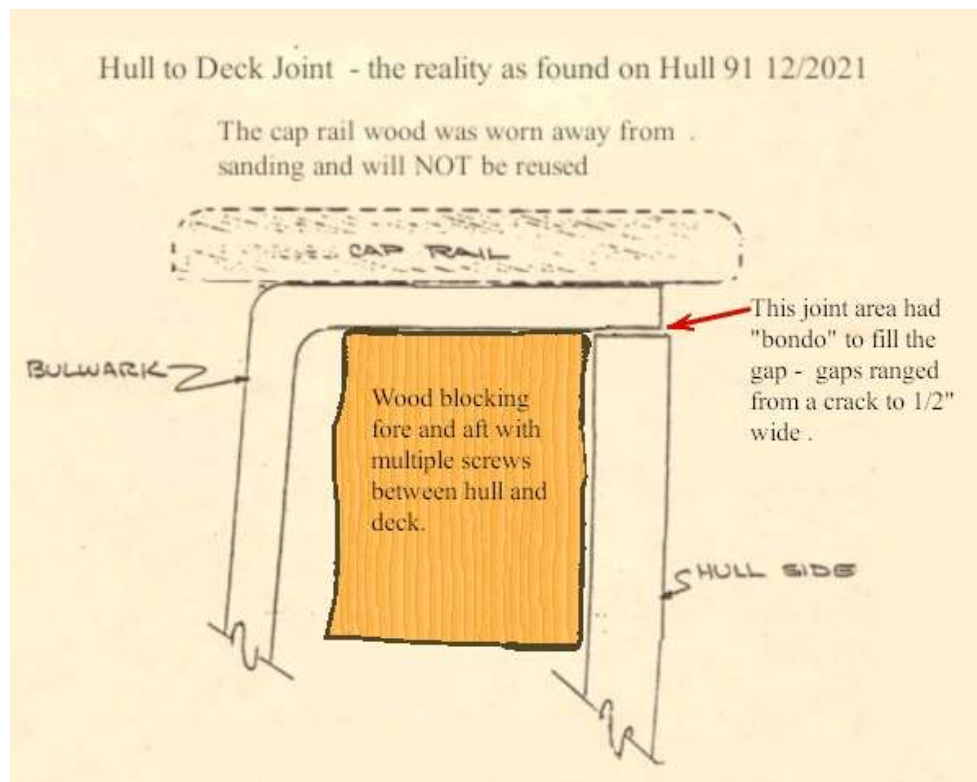
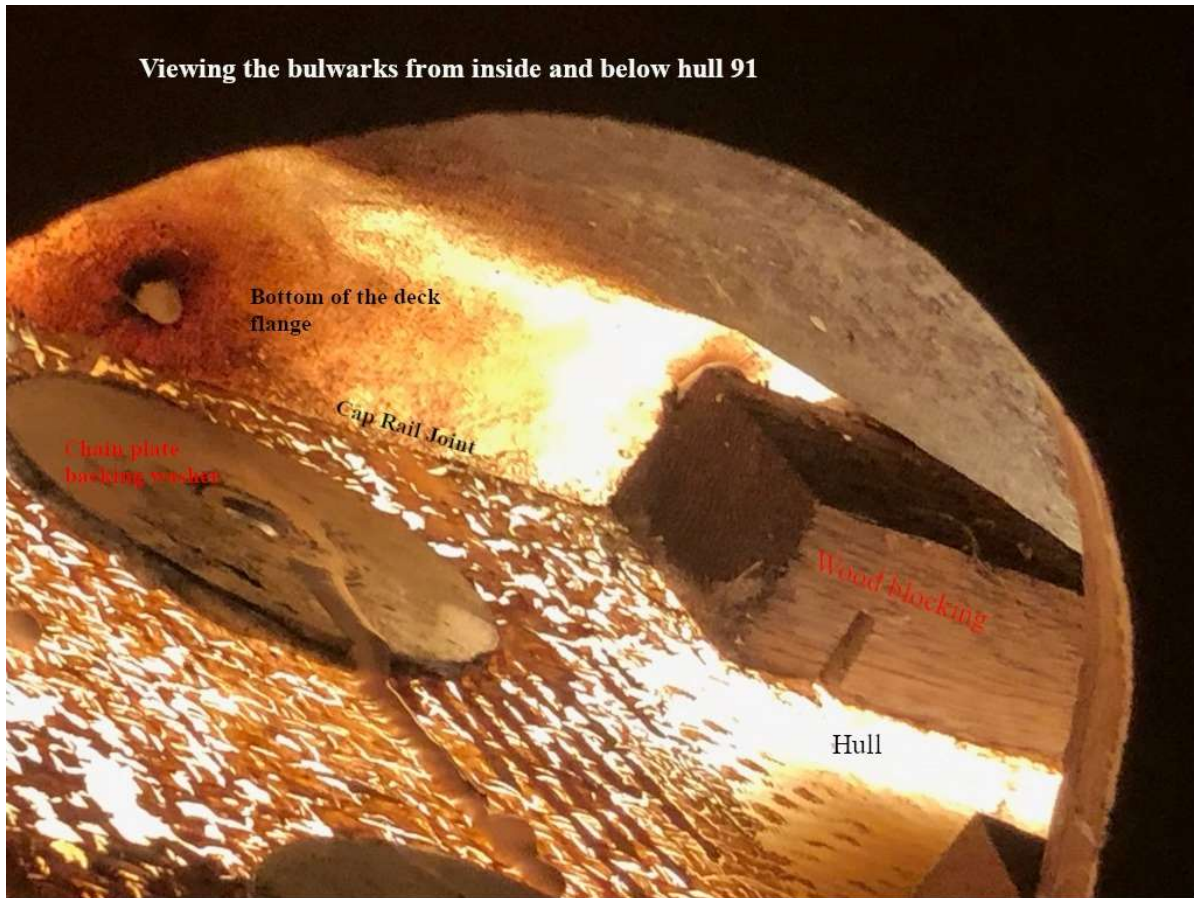
The **early vessels** are likely to have a hull deck joint as seen below. Stainless steel wood screws are installed down thru bulwark deck flange and horizontally thru the hull into the wood blocking. Smaller screws secure the cap rail to the top of the bulwarks, and large SS 5/16" lags are used to secure the jib track to the bulwark.

The leaks will occur thru the joint as well the many screws. Often water will run under the teak cap rail until a crack in the sealant is found.

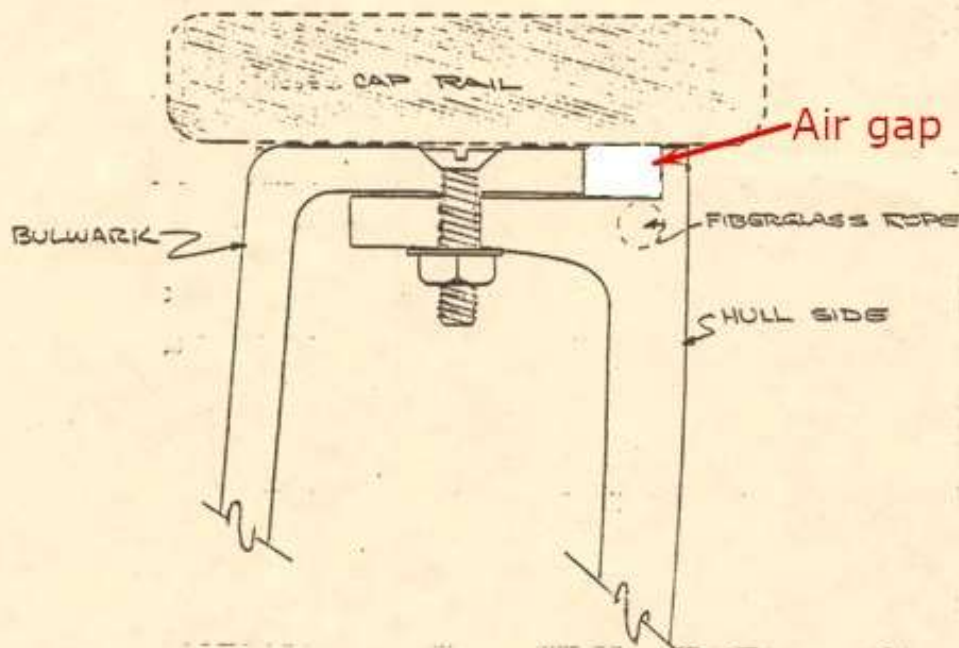
Hull to Deck Joint - Later model vessels

The water comes thru the cracks between the cap rail and top of the bulwark, collects in the **air gap** and then runs downhill to the low point in the hull/deck joint and into the interior of the boat.

Of course, the screws to fasten the cap rail down can also leak and there are > 200 of these screws.

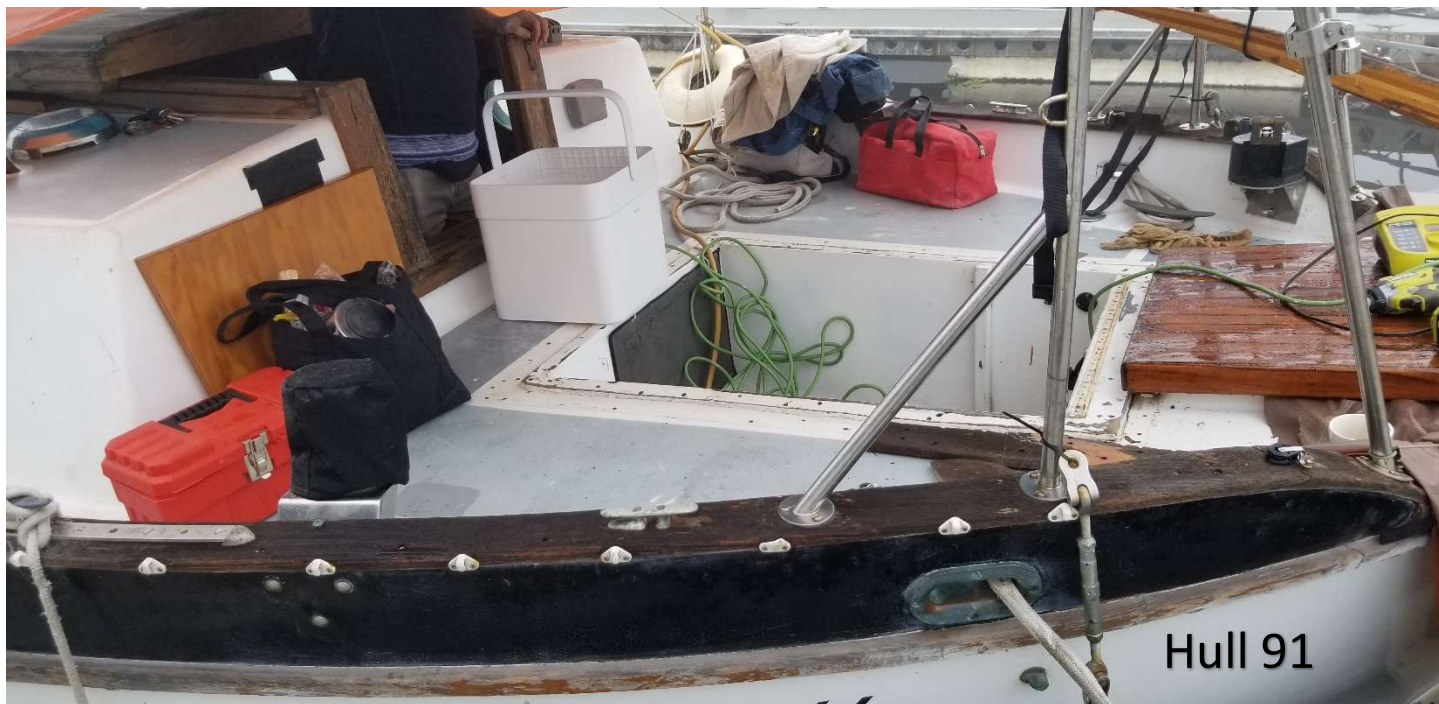
Depending on the amount of sanding and refinishing on the cap rails or if the teak is untreated, the cap rails maybe worn thin that reusing the teak as cap rails isn't a long-term solution. Below you can see the teak is in poor condition and getting thin.

If the existing teak is unusable – then the choices are to replace the teak with new teak or other product that would survive the elements or finishing the top of the bulwark with epoxy/paint/non-skid.

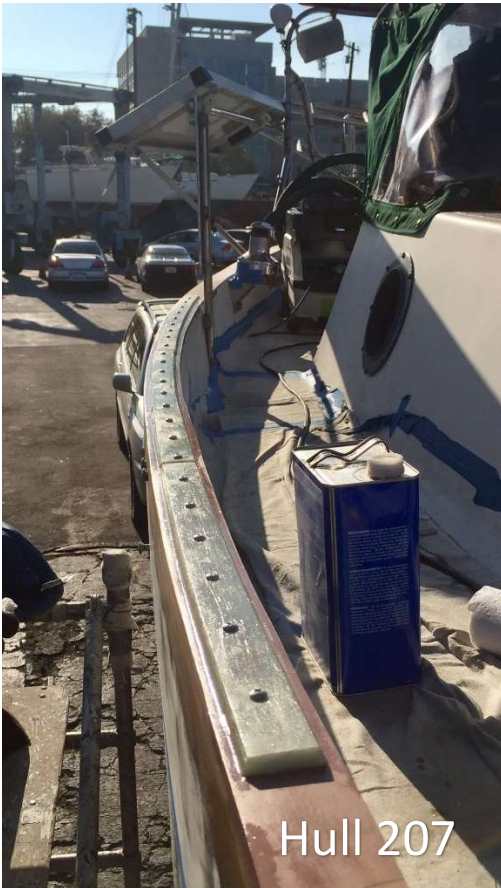
Above is hull 207 during installation of the ½" track riser. The screws are holding the riser down and in position during the epoxy cure and are removed when curing is complete.

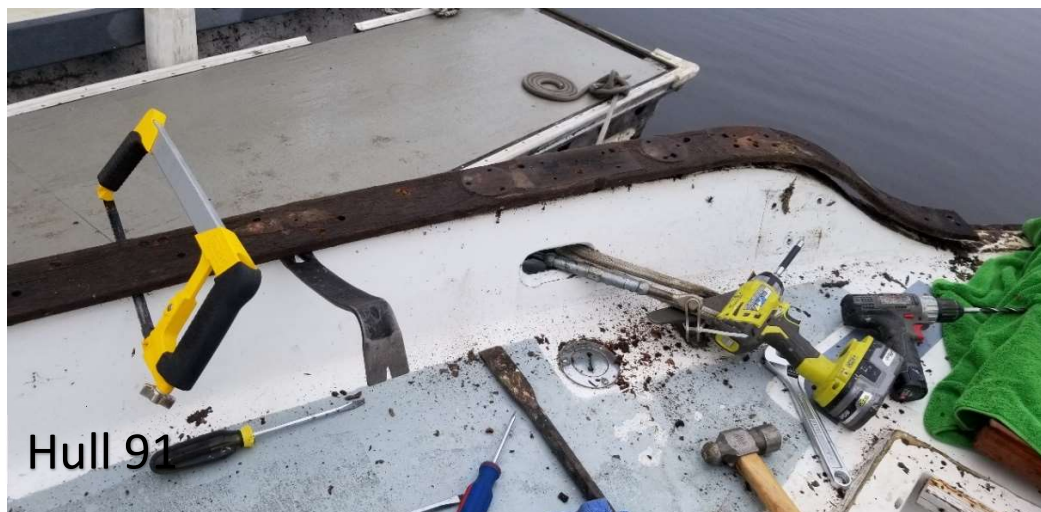
I've found that ~ 10% of the screws under teak plugs will not back out and had to be cut in half.

Remove the teak cap rail by removing the teak plugs, cleaning up the slot in the screw head and removing the screw. If the screw will not backout then a hack saw / sawzall can slip a blade between the teak cap rail and bulwark flange to cut the screw in half or drill off the head of the screw.

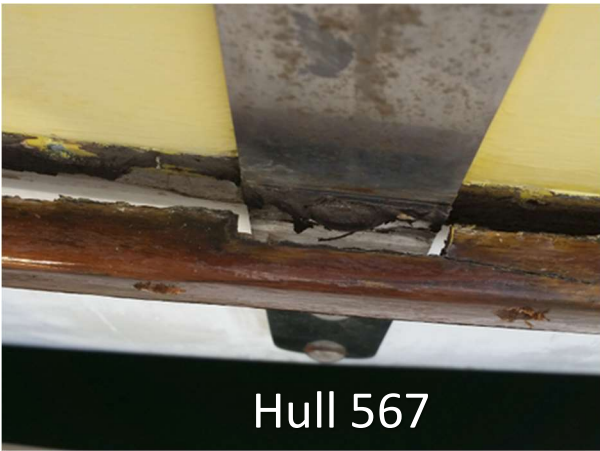
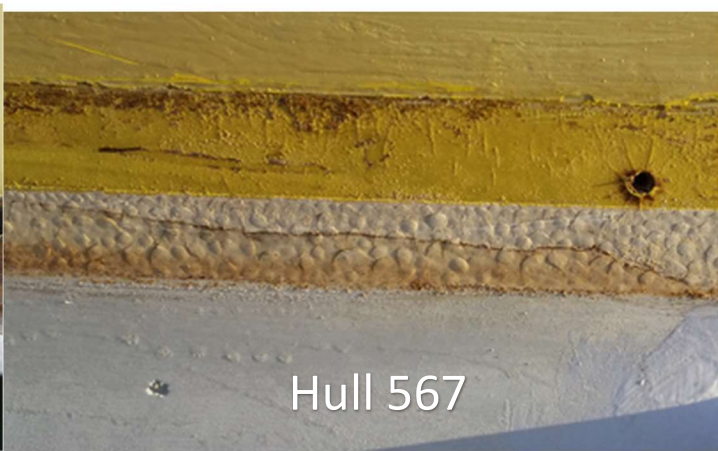
Below notice that the area behind the rub rail has collected stuff over time and has bubbled the jell coat. These loose bubbles should be sanded smooth, faired and painted before the rub rail is reinstalled.

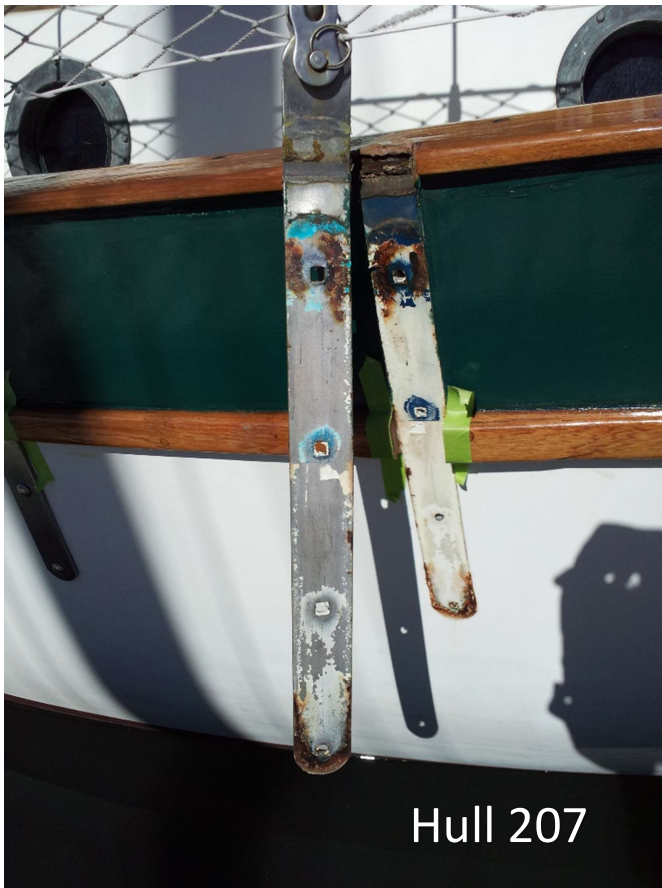
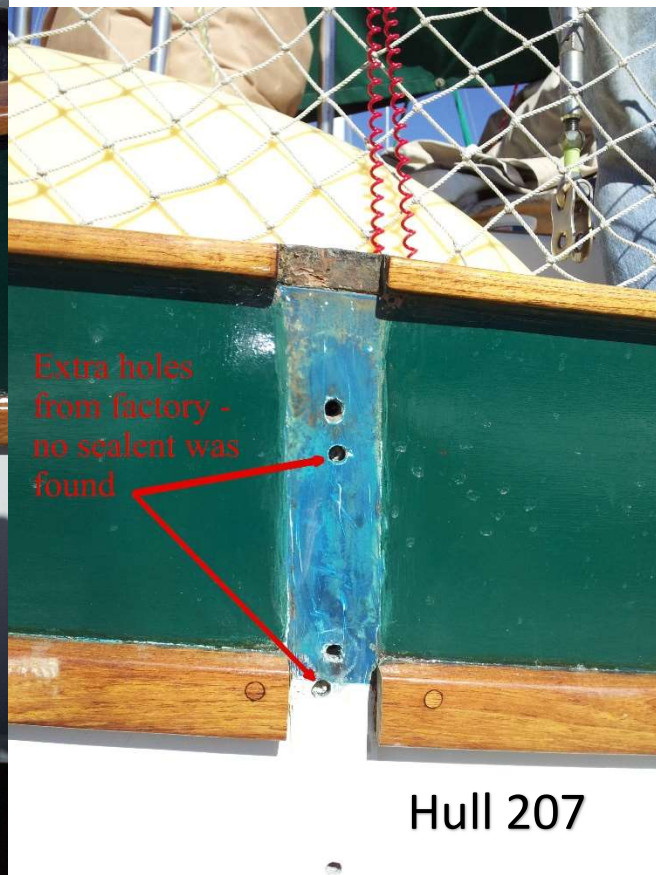
Below you see 2 extra holes were drilled thru the hull in error and hidden by the chain plate and the factory never sealed these holes. The extra holes should be cleaned up and sealed with thickened epoxy.

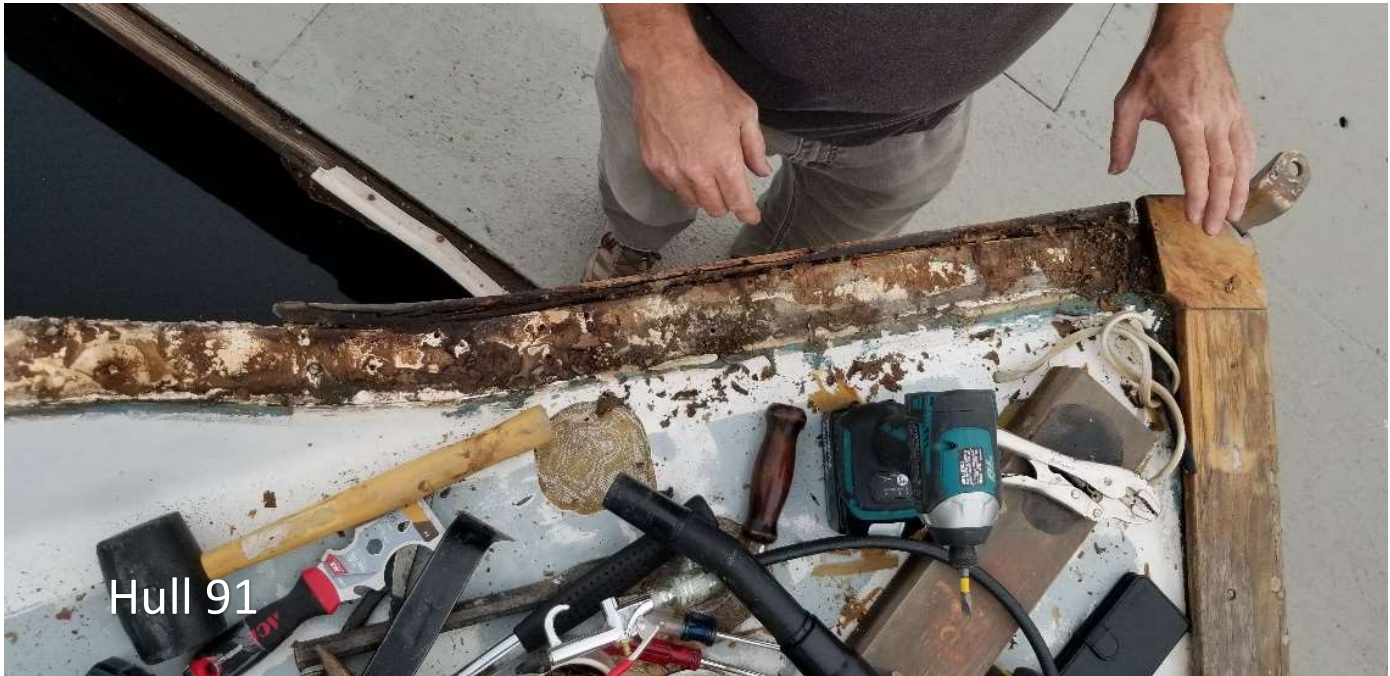
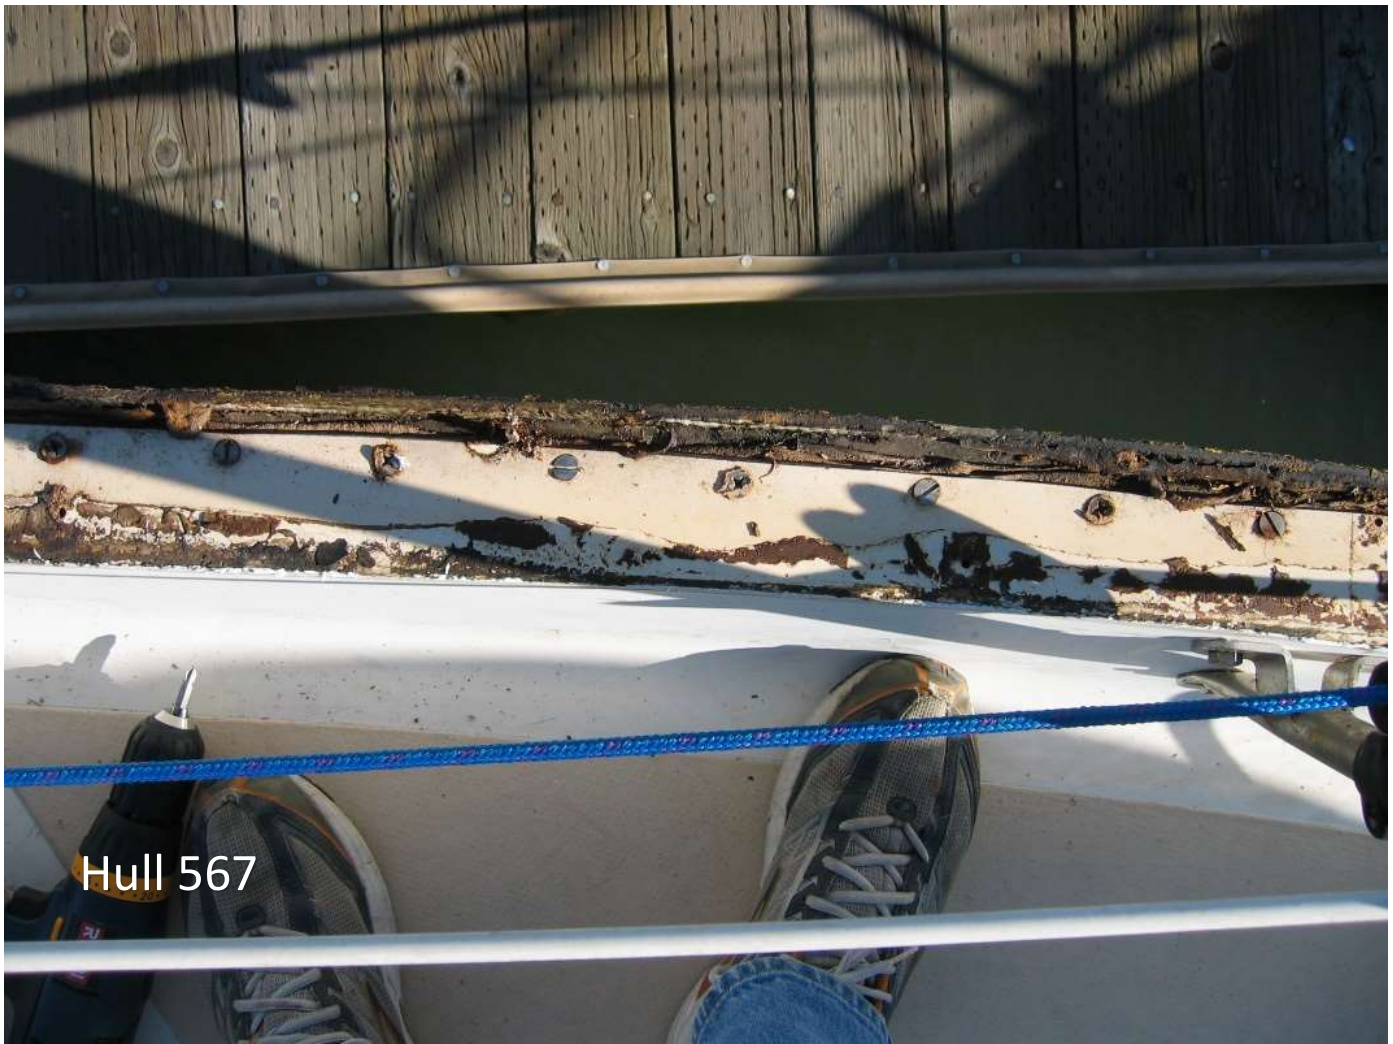
Joint area: After removing the cap rail, the joint area on the top is exposed and you can see the issues with the old sealant. The whole area needs to be cleaned of old material and sanded down to remove the gel coat and expose the fiberglass/resin. The SS screws that hold the deck and hull joint together need to be flush with the fiberglass, so the epoxy and fiberglass will lay down flat as possible.

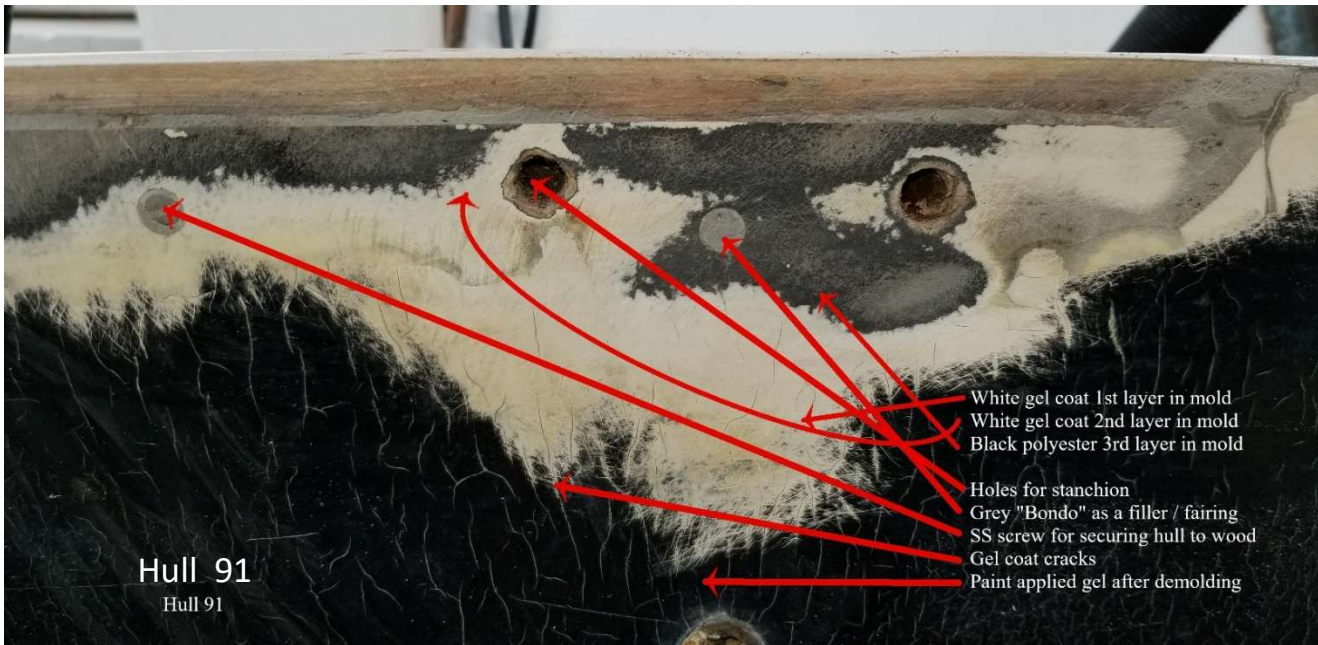
The older style of cap rail joint may/will require more work. Below is seen the large area where filler filled the gaping cracks and holes. Further, the hull side of the bulwarks needed heavy sanding to remove the cracking paint and gel coat.

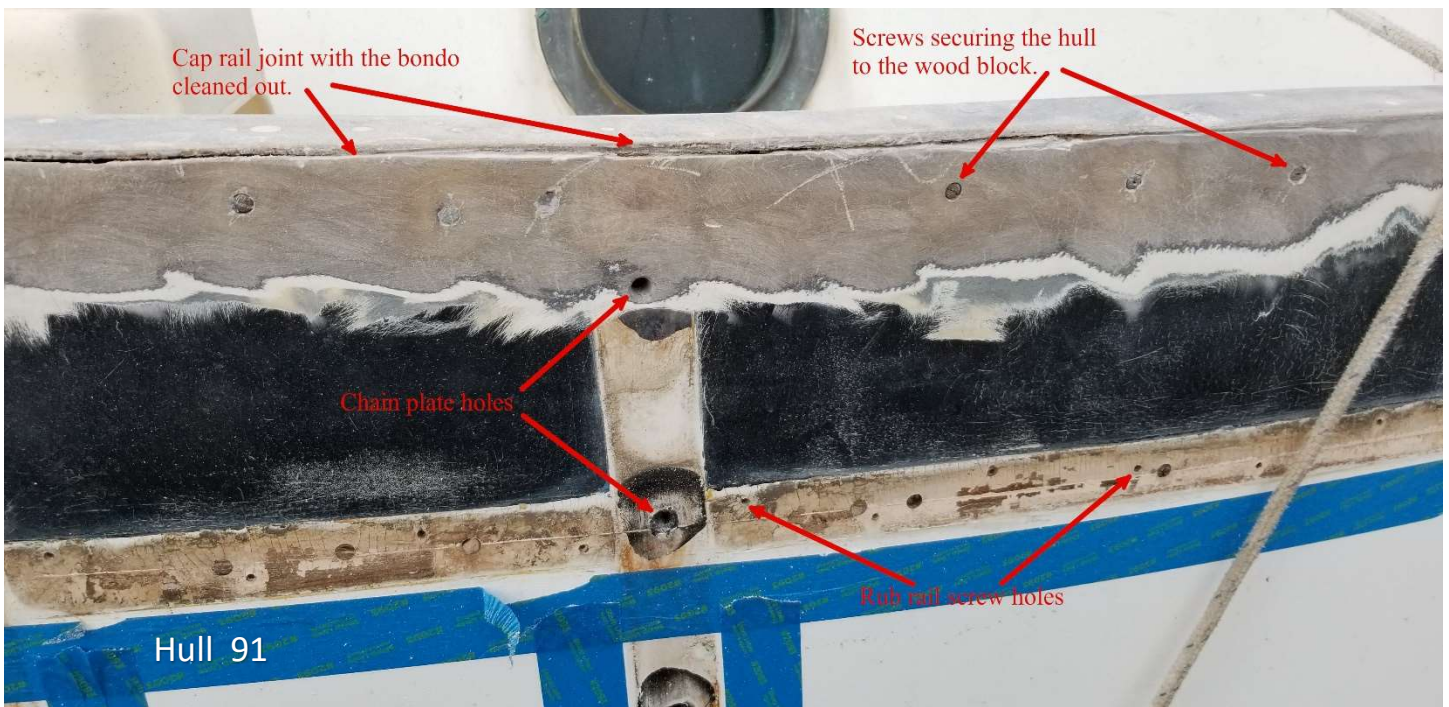
As the bulwark is sanded down to the raw fiberglass, layers of assorted colors can be seen. Remove any loose fiberglass or filler.

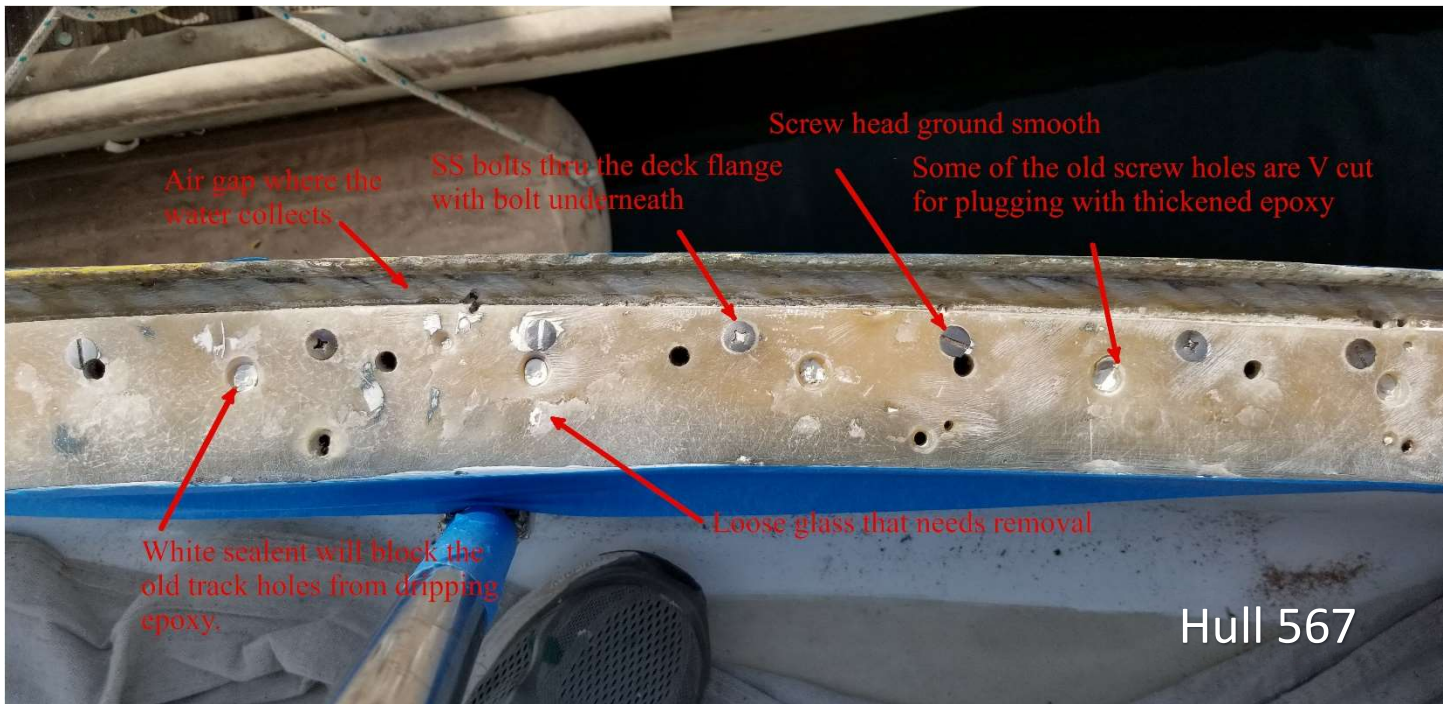
Hull #567 with the air gap marked – almost ready for epoxy and glass. First sand the cap rail smooth so the layers of fiberglass lay down well. The “clear” areas are fiberglass with the gel coat removed.

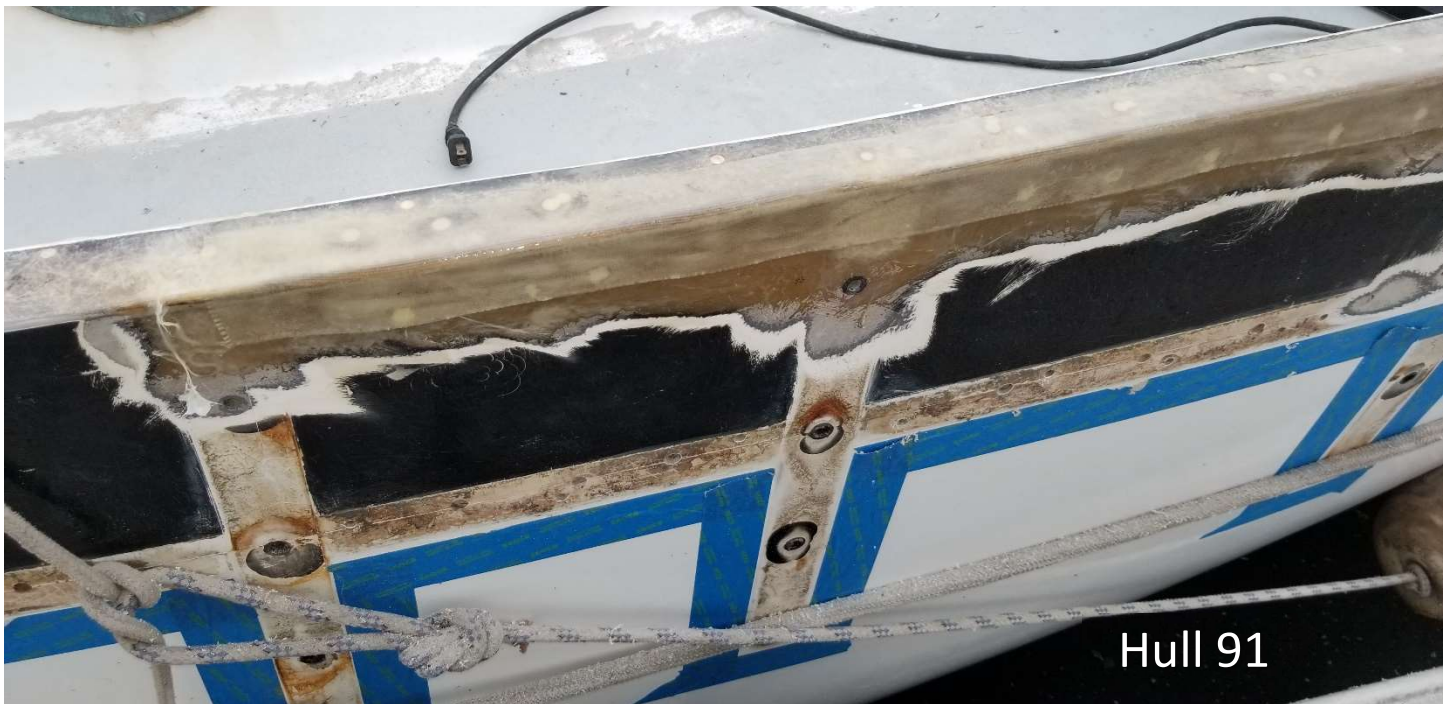
With the early design of the cap rail, the 3" fiberglass tape is applied $\frac{1}{2}$ on the top and down the side of the bulwarks. You do need to tend the corner area while the epoxy cures as the glass will try flattening out and form an air pocket.

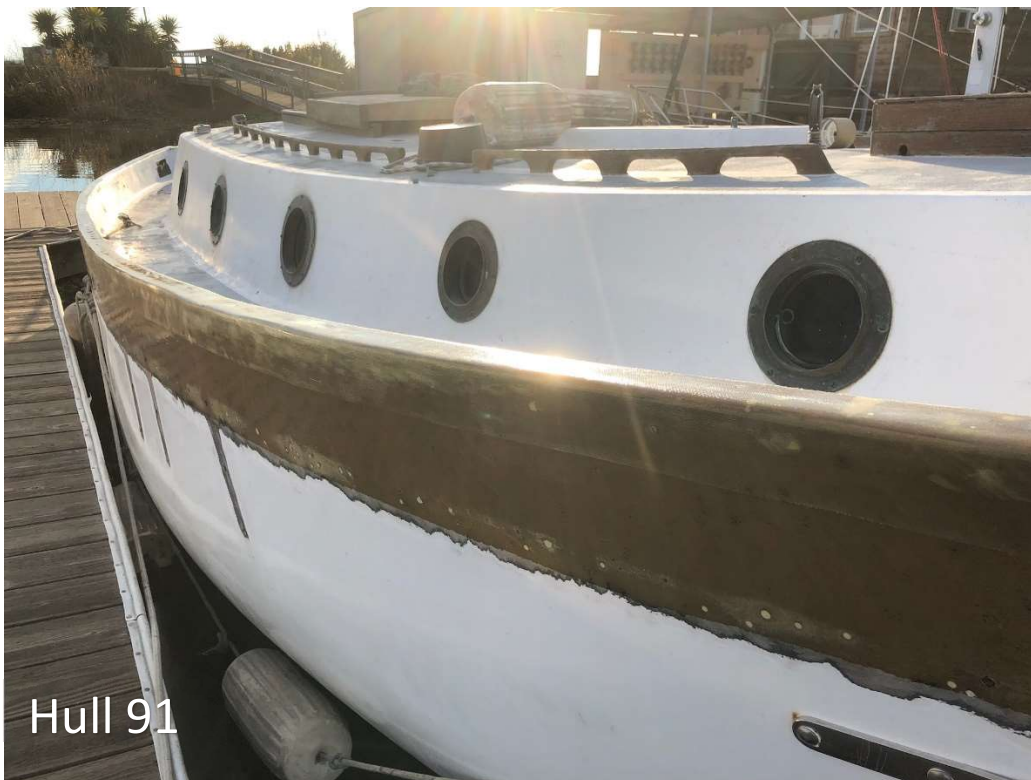
The second layer of epoxy and 3" fiberglass tape is installed off set from the first layer and will overlap further down on the outside.

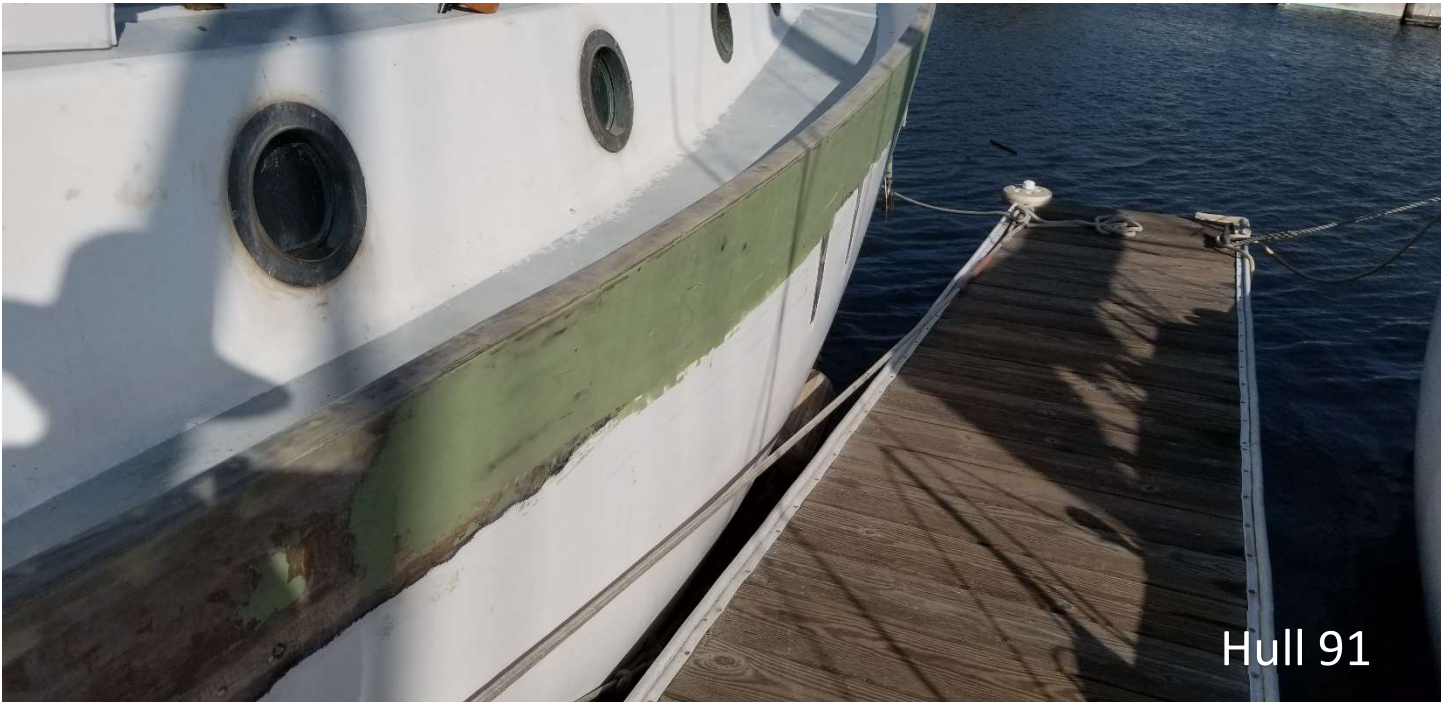
The 3rd and last layer will use 6" to 8" wide fiberglass tape and wrap from the inside edge of the cap rail to the rub rail area. Watch and remove any bubbles as the epoxy cures on each layer.

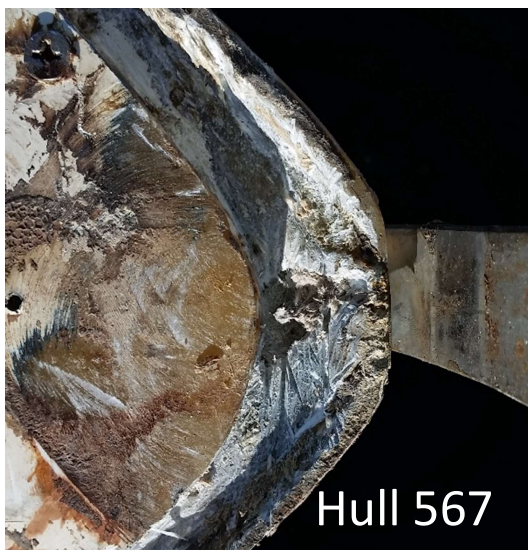
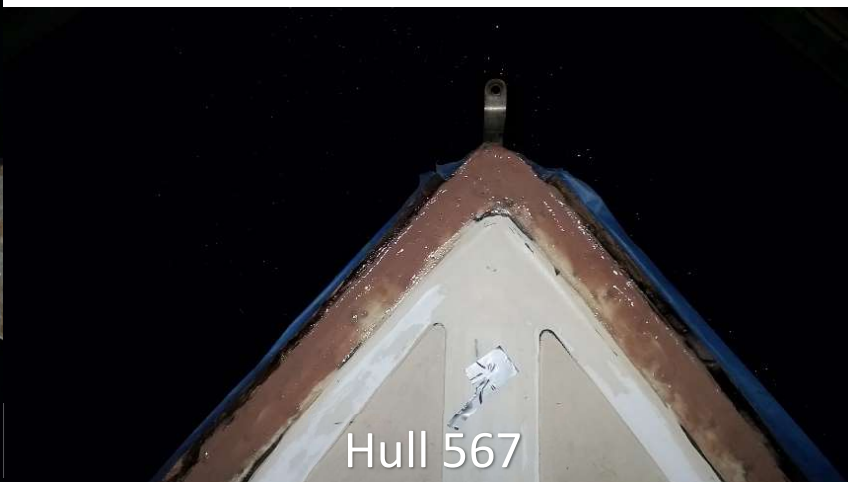
On #567 the upper part of the bow joint between the 2 hull halves was poorly bonded. A screwdriver was easily pushed vertically thru the soft filler and into the interior of the boat.

All this filler was cleaned out with scrapers and 40 - 80 grit abrasives. Epoxy and fiberglass were used to re-bond the joint.

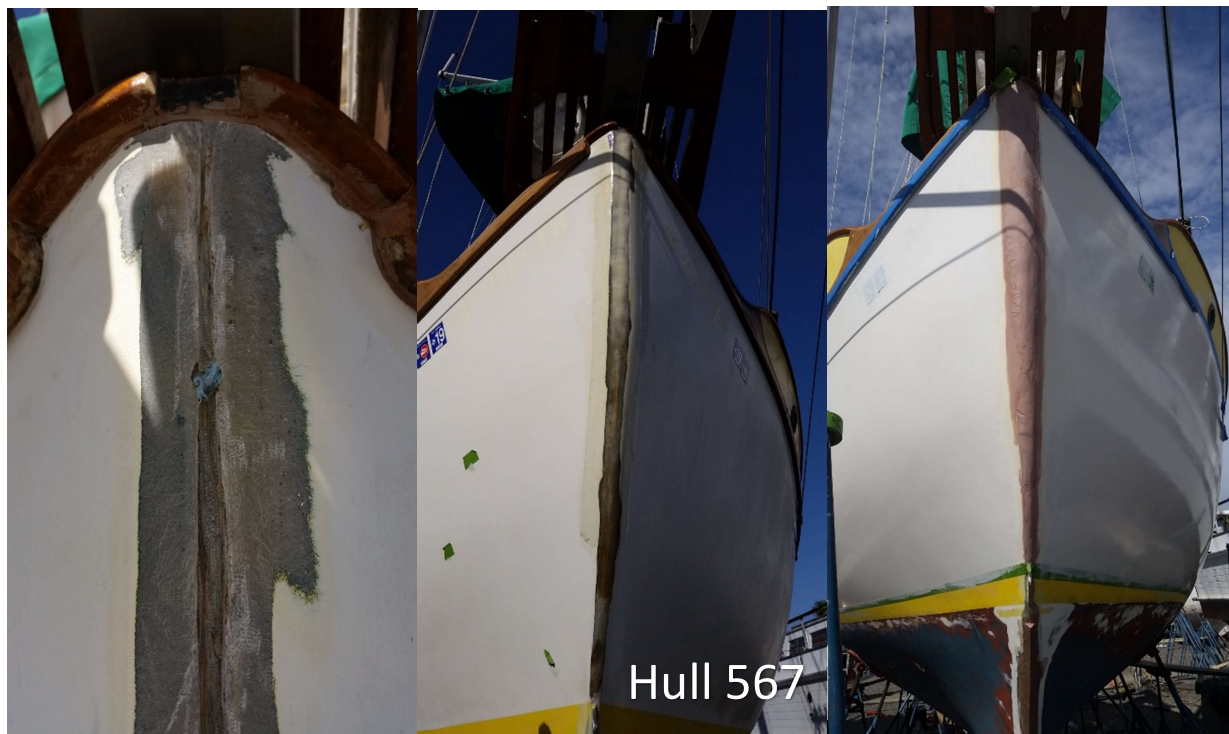
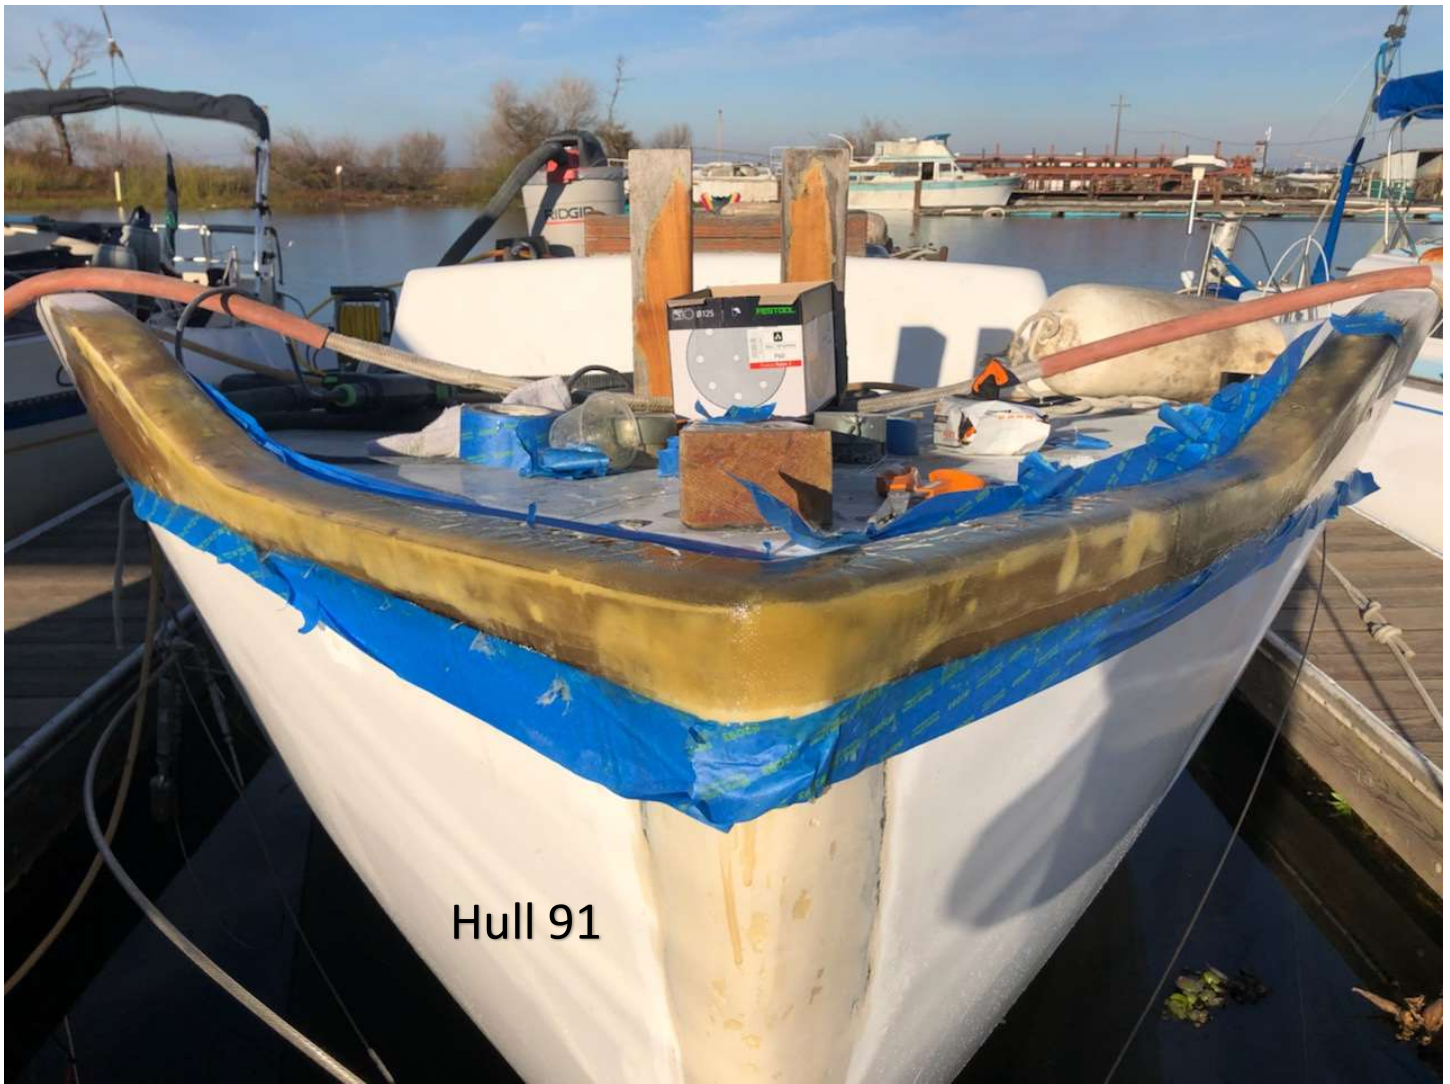
Hull 91

The bow and stern joint will often show a gel coat crack due to the soft fillers used.

In 2018, #567 was hauled out and the bow was cleaned down the joint to the water line. Remove the filler, clean the area and layer in thickened epoxy and fiberglass, fair and paint (not shown).

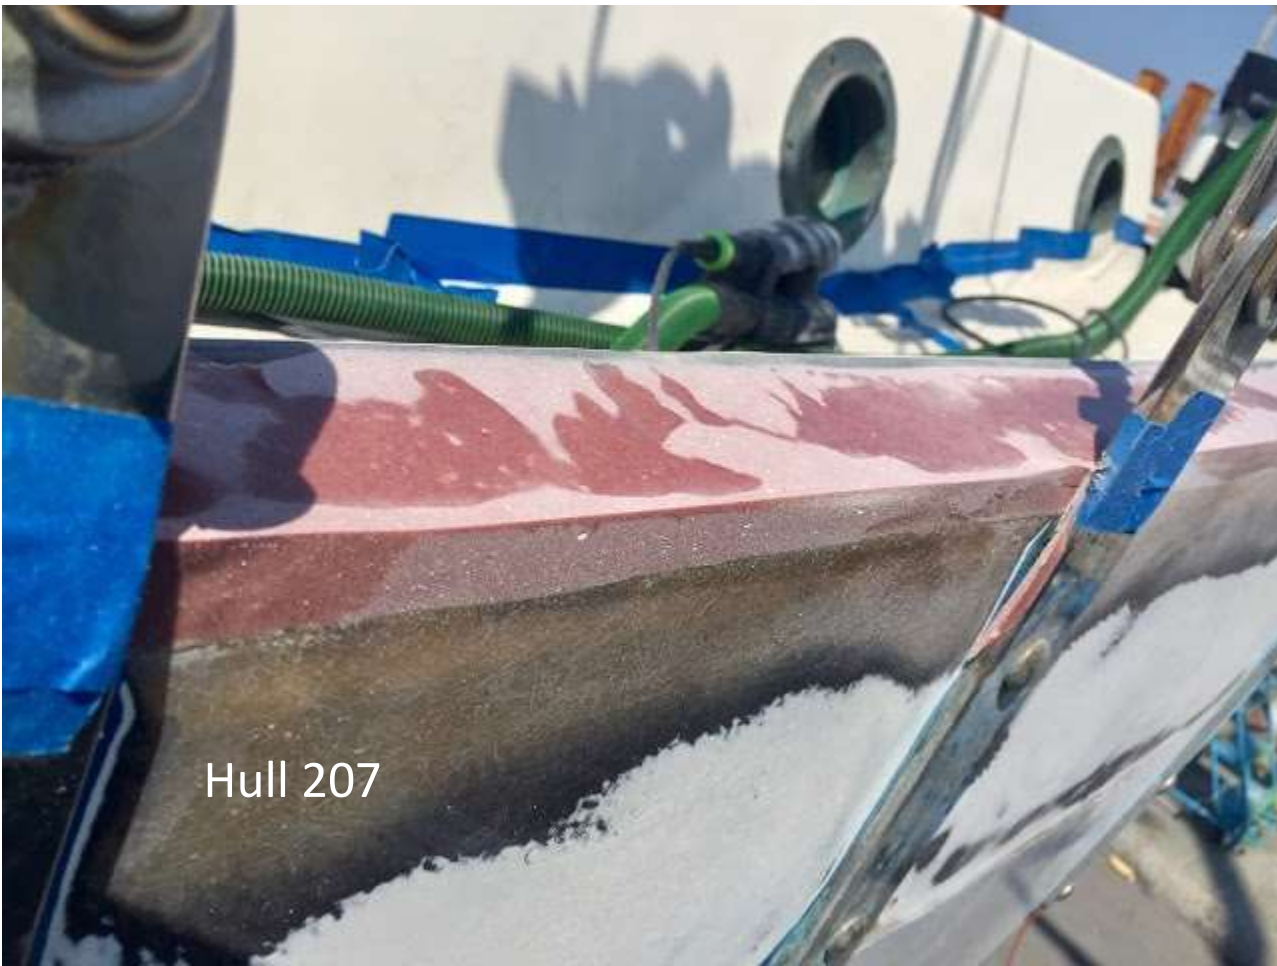
Some boats have a “low” area that was filled with filler at the factory to obtain a horizontal surface. Remove the filler and make tape dam which will be filled with thickened epoxy to achieve a horizontal surface.

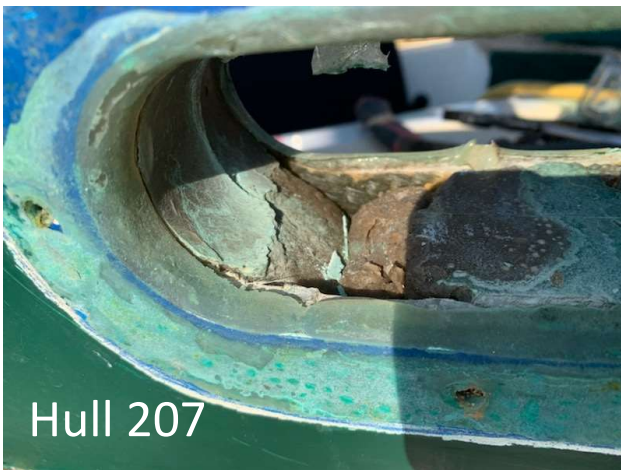
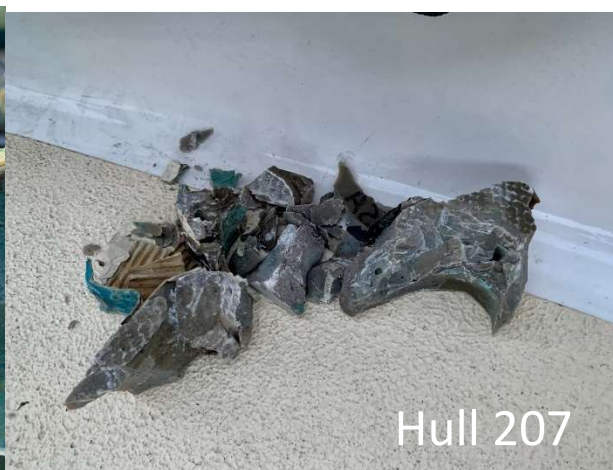
The hawse pipes are made of two pieces of cast bronze (#91 & #207) or spun brass (#567). The water leaks can be in the center where the hawse pipe halves join or from the flange and fasteners. The removal can be difficult if the fasteners become stuck. The area between the hull and bulwark can be a void or filled with filler and/or foam. By this time, the filler/foam has deteriorated and cracked.

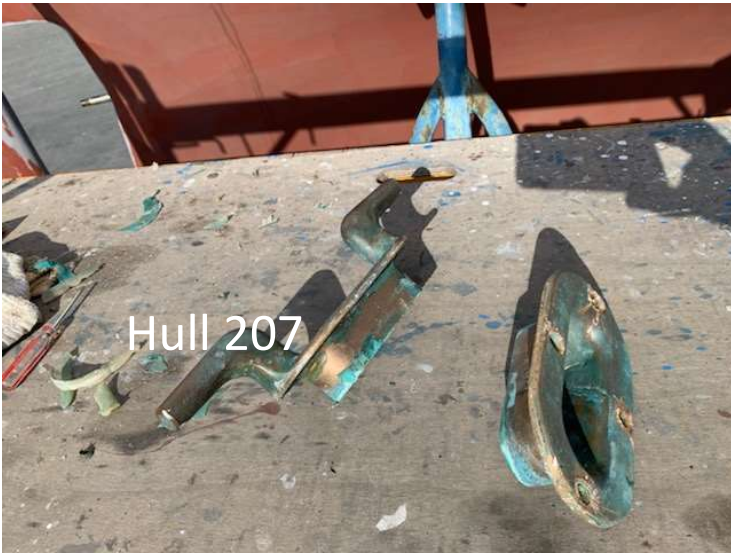
To support horn style hawse pipes, #207 used three stacked pieces of $\frac{3}{4}$ " plywood – soaked with thin epoxy to make watertight.
