Sealing the cap rail joint on Westsails

[Westsail #91 S/V Resolve](#) Jim Harrison
[Westsail #207 S/V Tortuga](#) -Randy Leasure
[Westsail # 567 S/V Pygmalion](#) – Jay Bietz

By Jay Bietz
6/2/2022

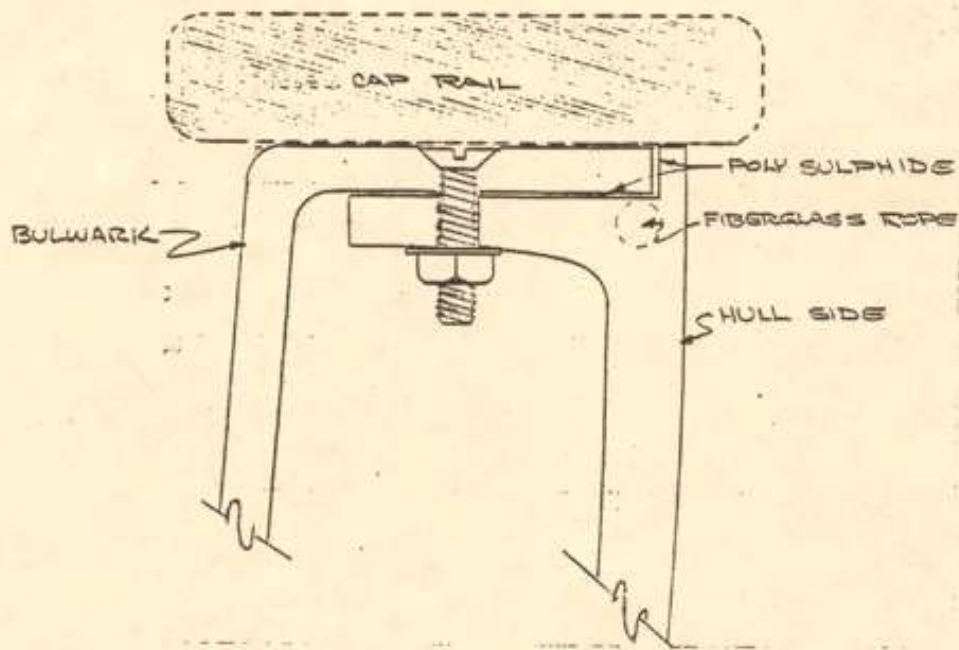
Hull to Deck Joint - the dream

For comparison, the joint in newer vessel (#567) is like the image below.

The water comes thru the cracks between the cap rail and top of the bulwark, collects in the **air gap** and then runs downhill to the low point in the hull/deck joint and into the interior of the boat.

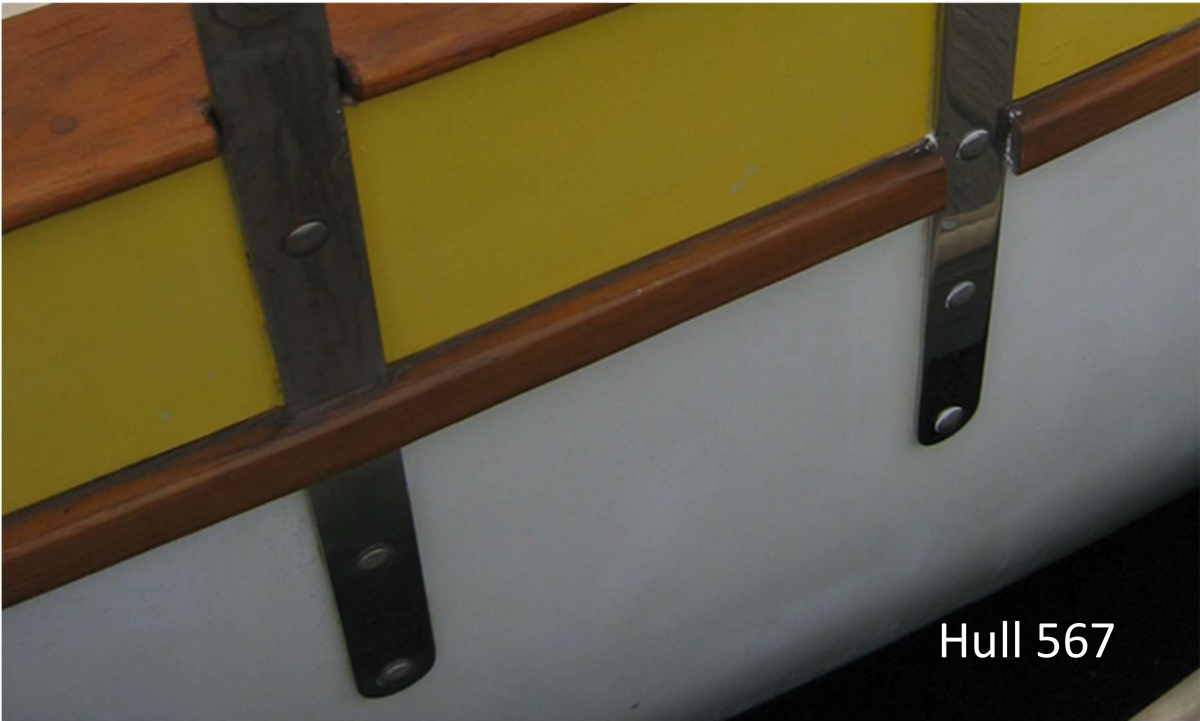
Below are two ways to manage the chain plate and rub rail. Another thought is to slope the exposed ends of the rub rail.

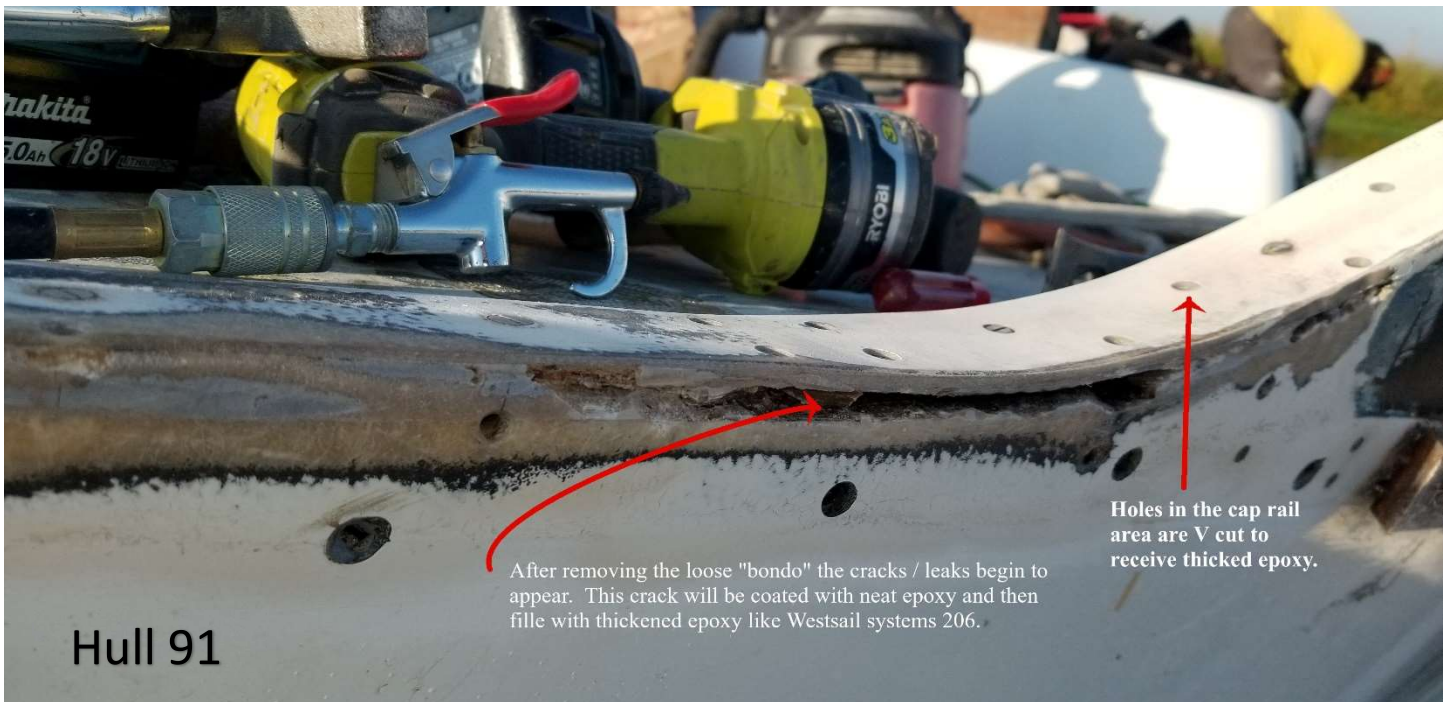
Repairs to the area can begin when all the holes are beveled, and all the loose fiberglass has been removed.

We will be coating the beveled holes in the cap rail and rub rail area, cracks, and gaps with a coat of neat epoxy and while the neat epoxy is tacky the thickened epoxy will be used to fill the screw/bolt holes. You may need to tape up the bottom of the holes as the epoxy may drip.

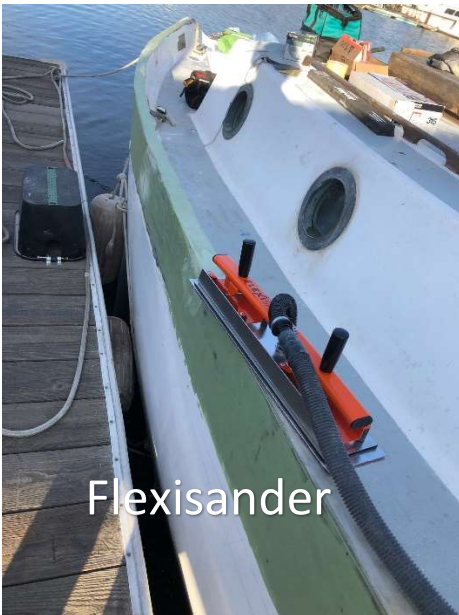
After the 3rd layer of glass, Total Boat Totalfair was used to fair the bulwarks using larger plastic epoxy spreaders. When cured longboard sanders will be used to fair the top and sides as needed.

A second/third coat of fairing will probably be needed to bring the surface to a flat and smooth surface.

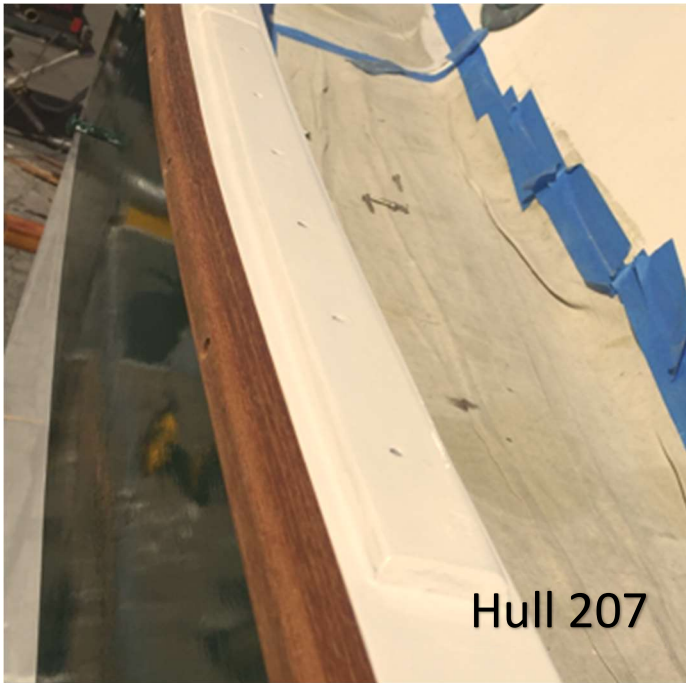
If an eyebrow will be installed, then the outside edge should be curved smooth, and the corner squared off so the eyebrow will be tight against the edge of the joint.

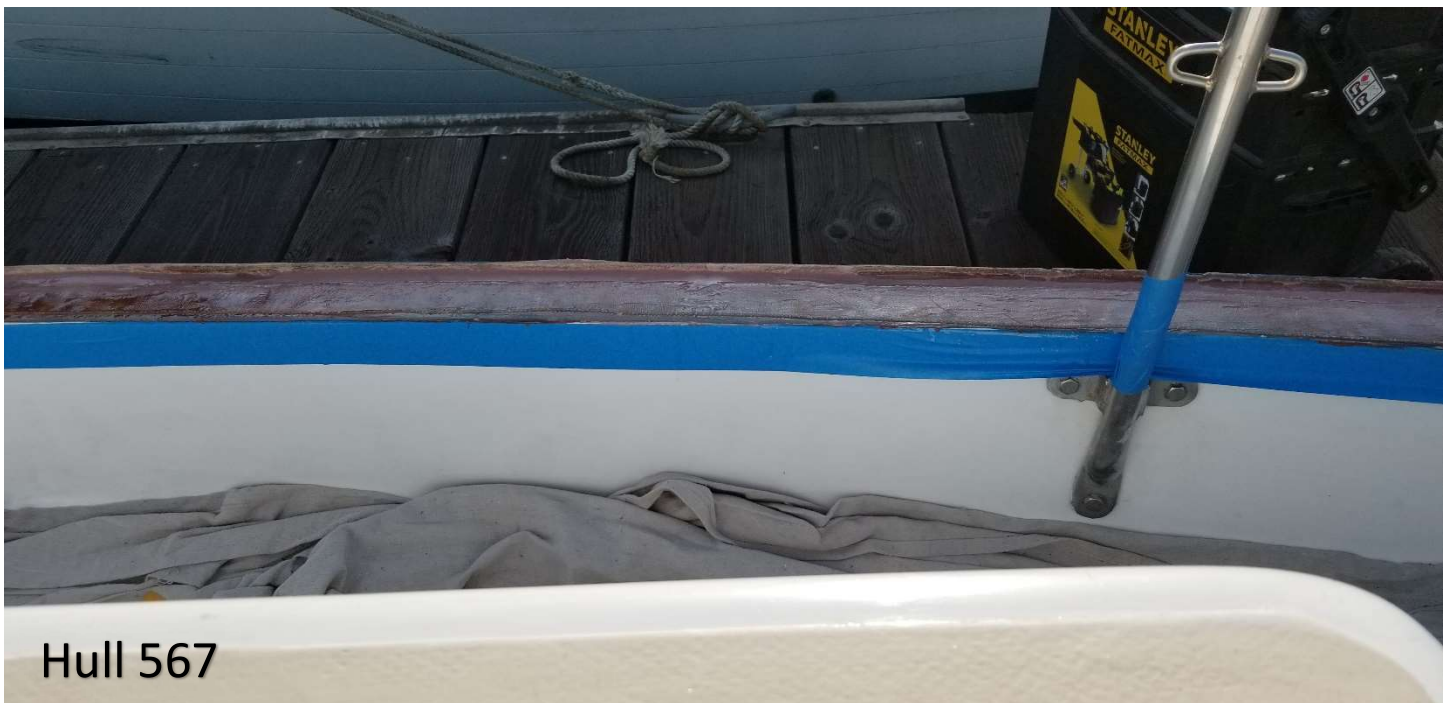
The epoxy in the first layer of fiberglass should be kept thin for a good bond with the deck and hull fiberglass. Be sure to sand to about 80 grit or lower and remove all dust by vacuum and wiping with acetone/cleaner. Use neat epoxy and coat the surfaces with a thin coat, lay in the 3" fiberglass starting at the inside corner and following the contour with the excess on the outside edge. Add thickened epoxy to complete the first layer and remove air bubbles as needed.

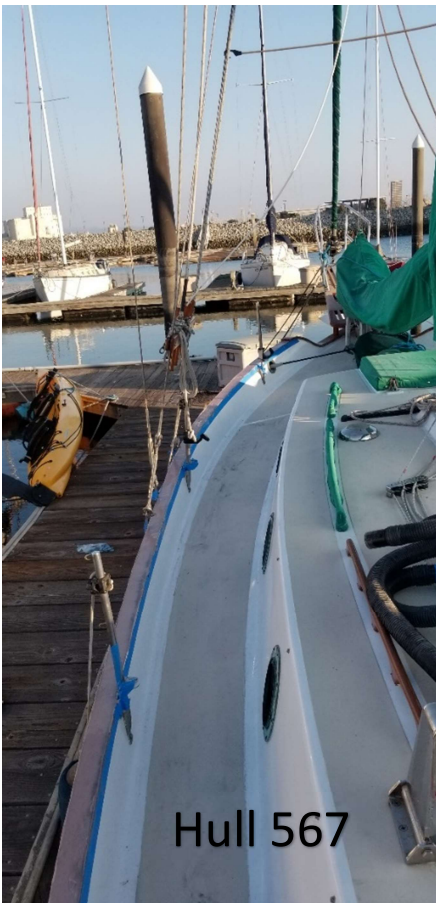
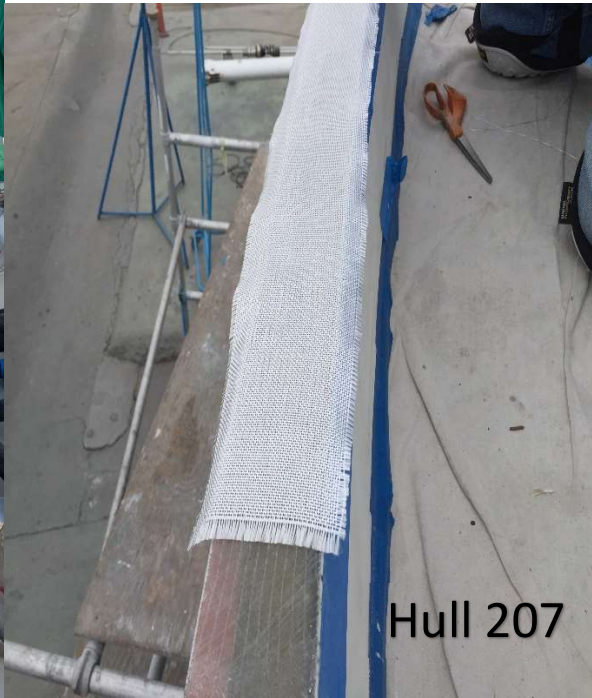
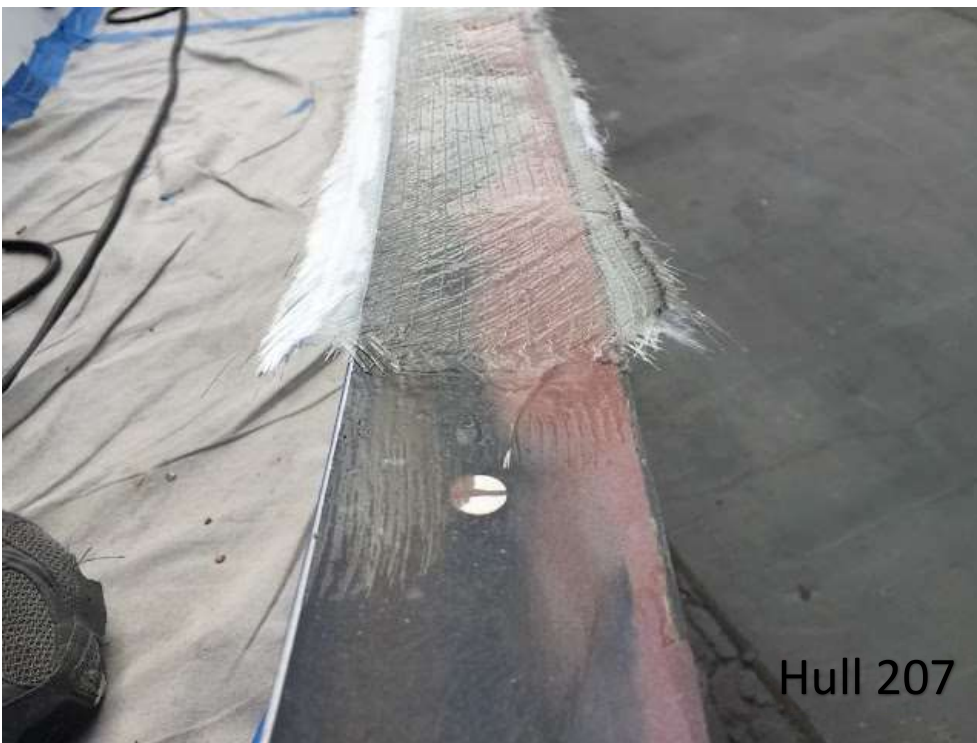
Prep for the second layer by sanding off the high spots and removing the epoxy "blush" by sanding then cleaner/acetone.

The second layer of fiber glass and more thickened epoxy will fill in the uneven areas from the first layer and you want to leave the surface flat and horizontal. Owners may want to add a 3rd lay of epoxy/glass for additional strength.

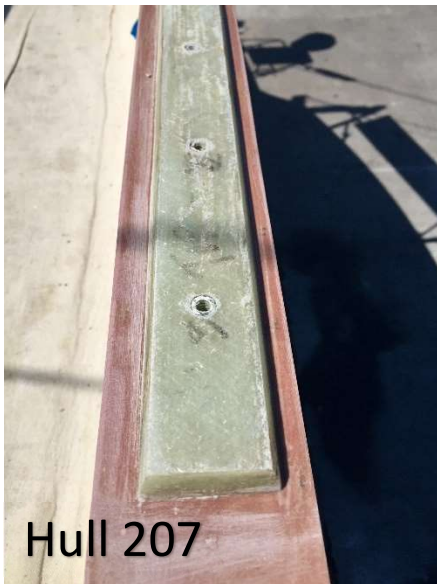
To support the jib track, a .5" thick piece of epoxy/glass or G10 will be epoxied to the cap rail. Find the position the for the track forward or back at least 1 inch from the original position. Predrilling the holes in the jig track riser is not recommended as drilling and tapping the holes will be done with the jib track as a template.

Another consideration is to plan for a gap in the track support in the lowest area of the cap rail so standing water can drain seaward.

I also recommend that the track bolts be SS Phillips flat head for ease of power tightening the bolts.

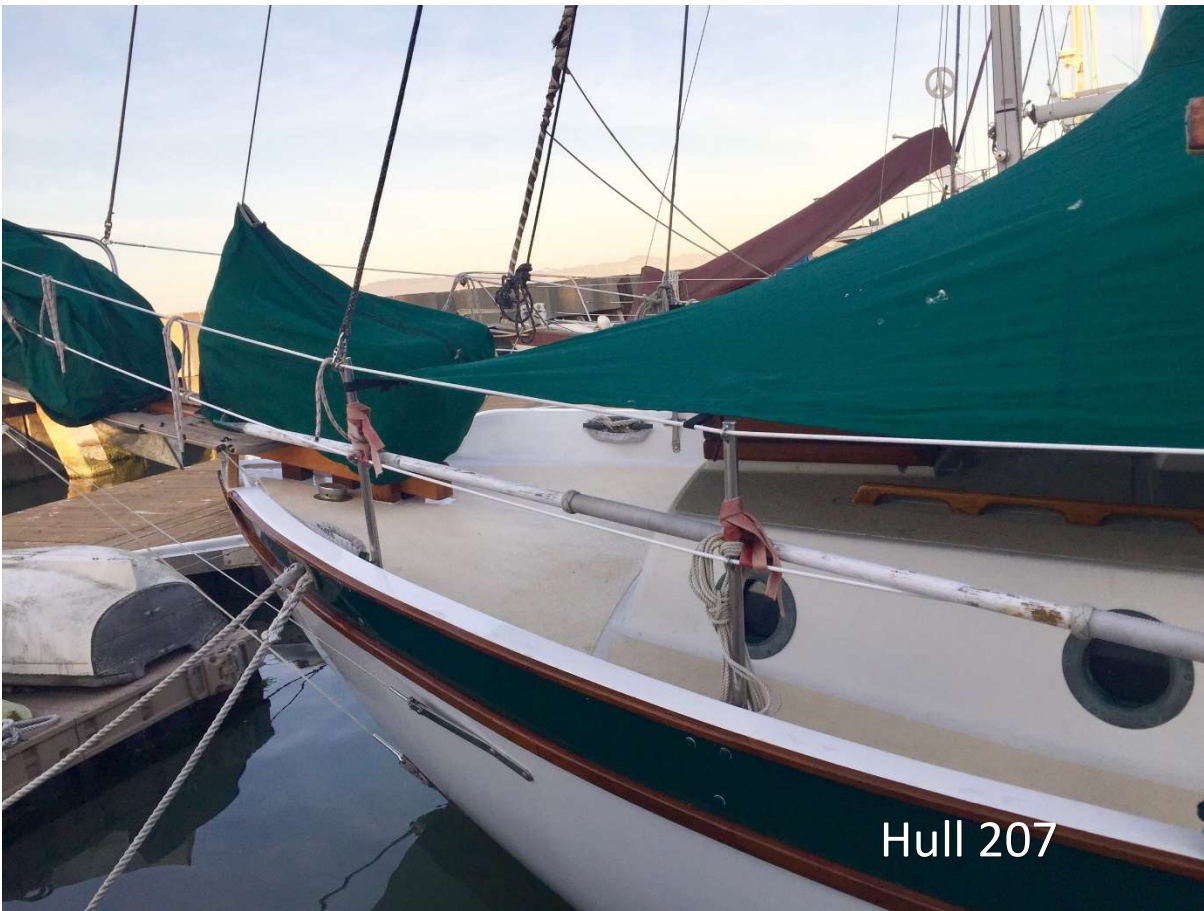
When finished, remove the jib track, clean the area, and plug with thickened epoxy any of the small holes needed to position the track riser.

Before the jib track is installed, apply the anti-skid/paint to the cap rail and track riser as desired.

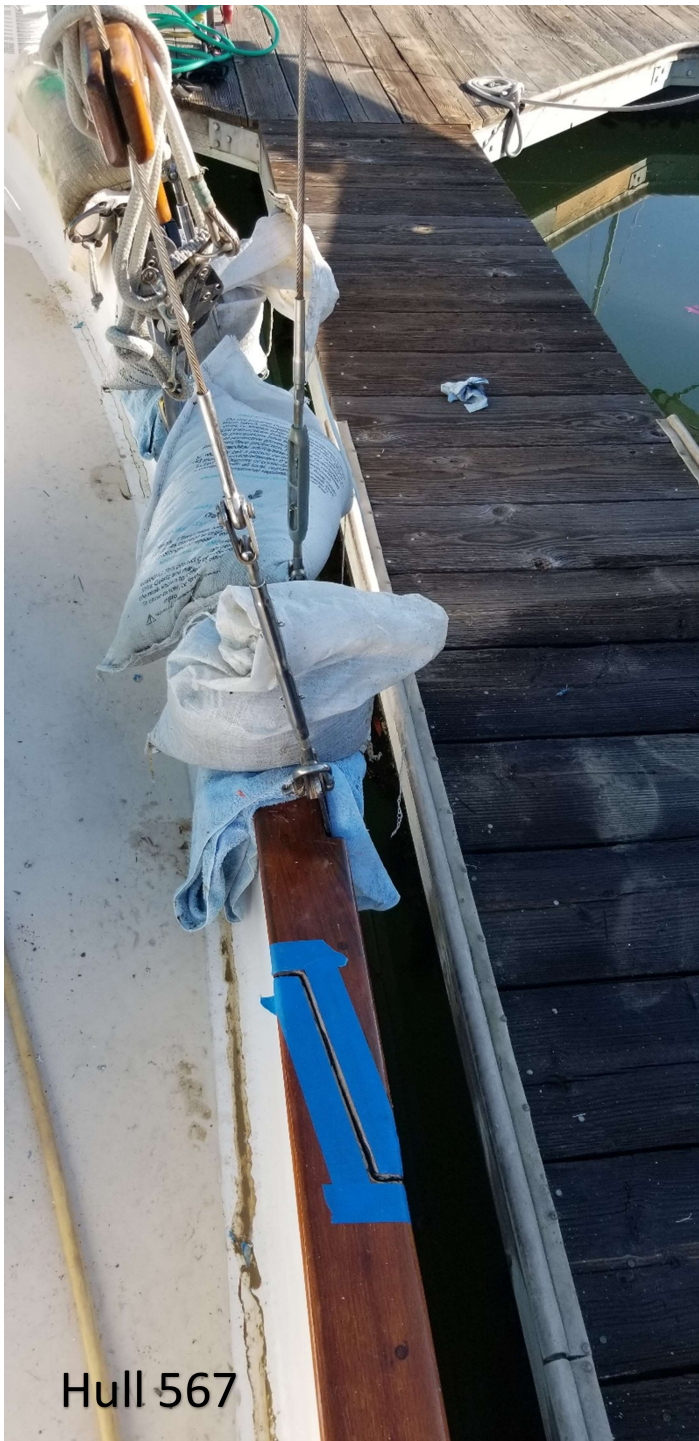
Hull 567

The forward teak cap rails are installed with your sealant/adhesive and held in place with water buckets and/or sandbags. Each joint is sealed with UV resistant sealant.

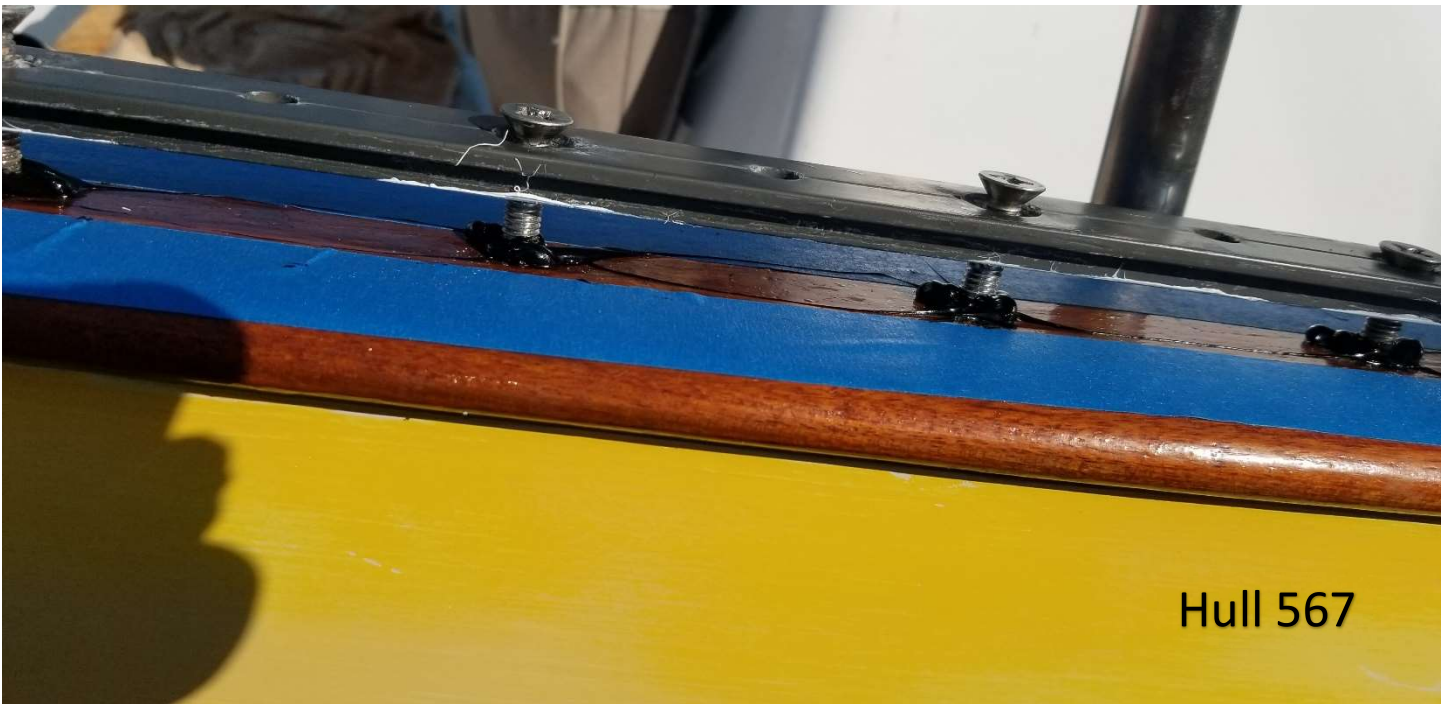
Install the jib track after the cap rail paint is cured or the teak is reinstalled. Use sealent under the track and around the head of the track bolt. The idea is to seal the track and track bolt to the track support as well as insulating the SS bolt from the aluminum of the jig track to prevent electrolysis corrosion.

I found that by using longer then required bolts and partially installing the bolts, I could add in the sealent with the track bent to the curve of the boat.

If the jib track bolts do not tighten (the threads are damaged) add a washer and nut from the inside.

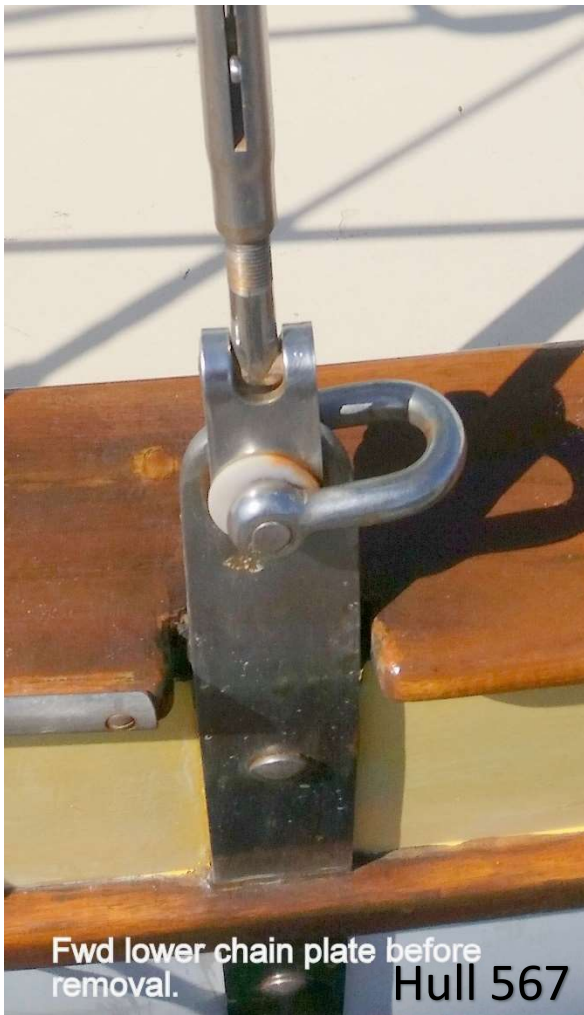
Since the track will be installed about an inch forward or aft of the original position the large bolt holes will need to be plugged with teak plugs and epoxied in place. The existing 3/8" holes for the screws holding down the teak may also need to be plugged. Sometimes the plug area was damaged from removing the plug and screws. Use a larger teak plug to repair the area.

Consider enlarging the slots in the teak for the chain plates and any semi-circles for the stanchions. Enlarging these area makes installation easier and there is room to add sealant to keep water from standing in the cracks.

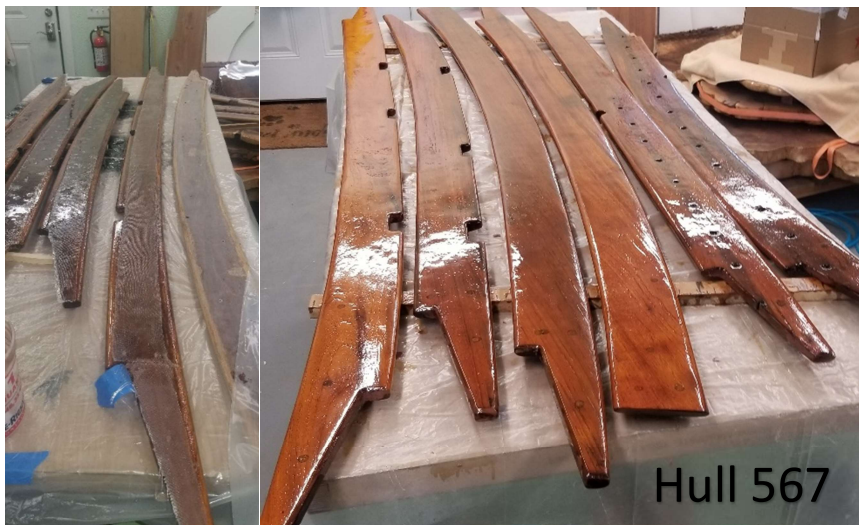
Epoxying a 3" fiberglass tape to the back of the teak will strengthen the teak. The bottom is also refinished with the same finish as the top.

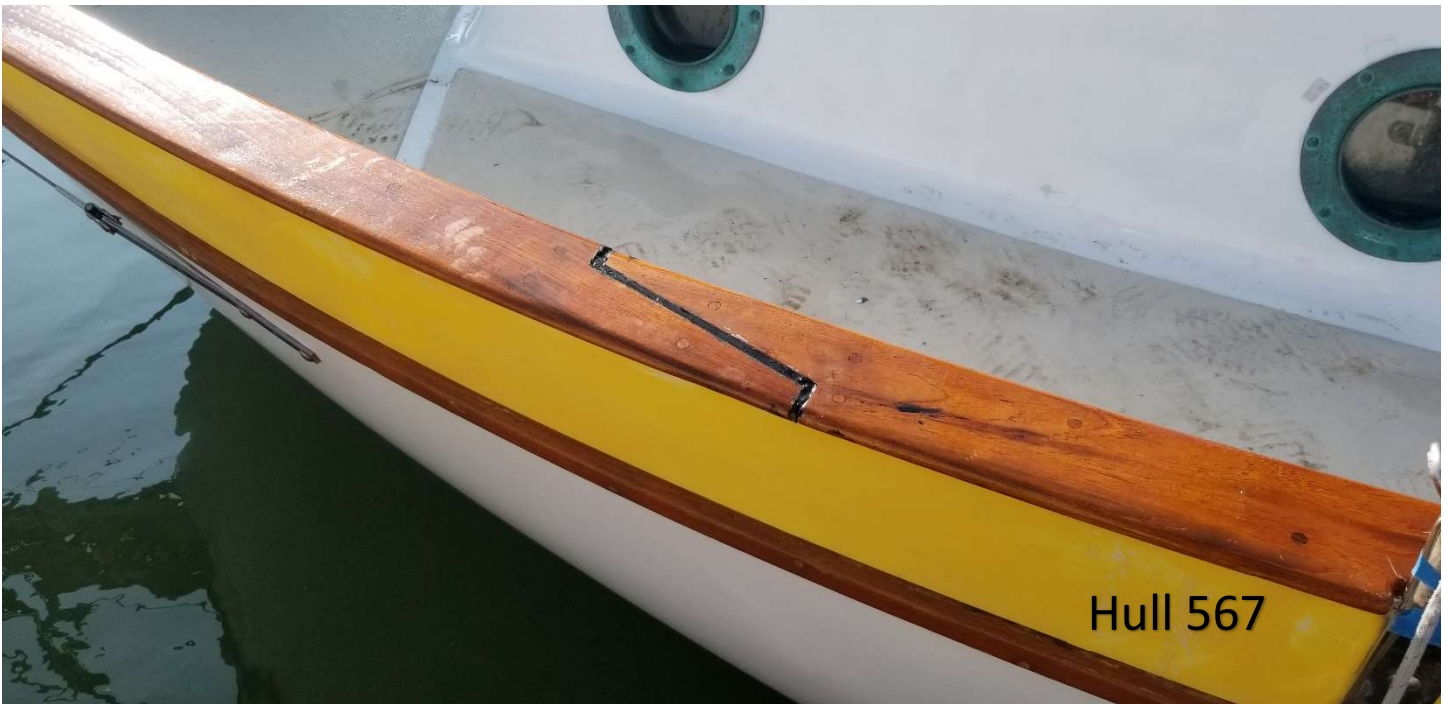
I've given up with getting the joints to be as tight as the joints done by the factory. I found that the water would gather in the crack and begin to undermine the finish.

Below I've beveled the top edges of the joint and used black UV resistant sealant to fill the bevel. Another idea is to trim off 1/4" of teak from one side of the joint and fill the whole gap with the same sealant.

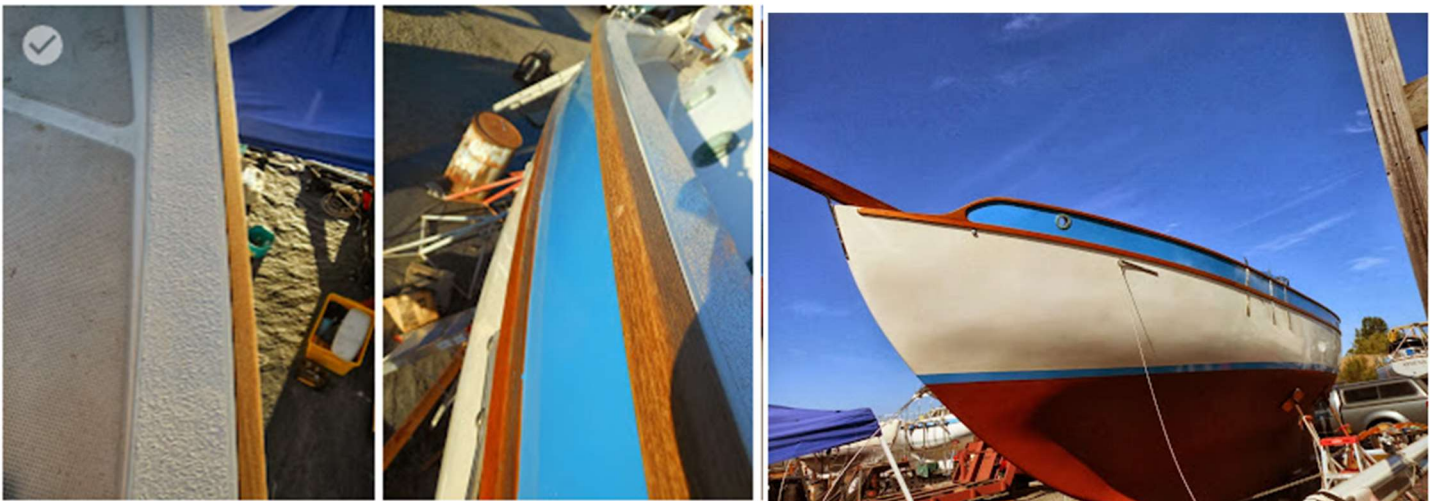
There are many finishes for teak each with pros and cons – here is Sitka Cetol Natural with 3 coats for the under coat and the topcoats with Sitka Cetol gloss. A second gloss coat will complete the finish.

Here are a few pics of finished cap rail repairs.

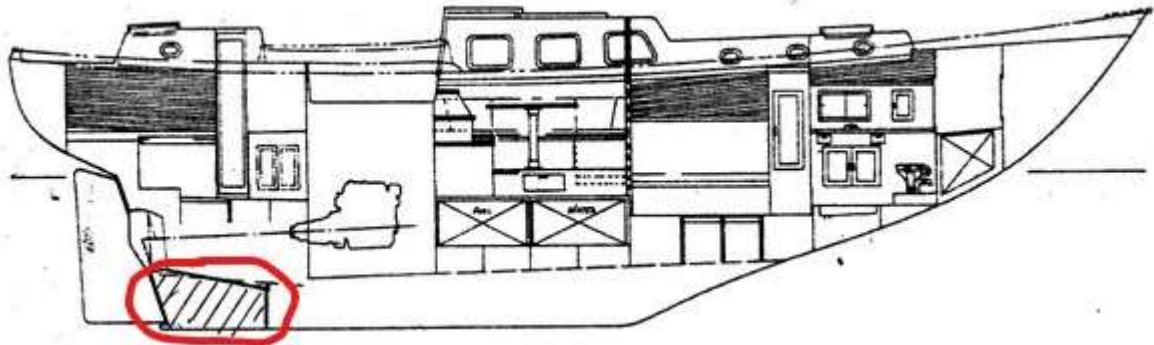
"The W42 and W43 hulls were molded in three pieces, then bonded together. We knew that to reach down to try to center bond the hulls down at the lower end of the keel, it would be practically impossible. So, we made a small third mold of the aft end of the keel and attached it part way up the keel where it could be reached. The joint line can be seen if the bottom paint is removed from the aft end of the keel. It was done so that the center bonding was along the keel where it could be reached, instead of down deep on the centerline where it was doubtful the laminator could get a decent bond line. I thought I had a picture of that but could not find one. The piece went about 4 to 5 feet forward along the bottom, about 3 feet or so up the keel. I have attached a sketch of about what that third piece looked like (circled in red), to the best of my recollection."

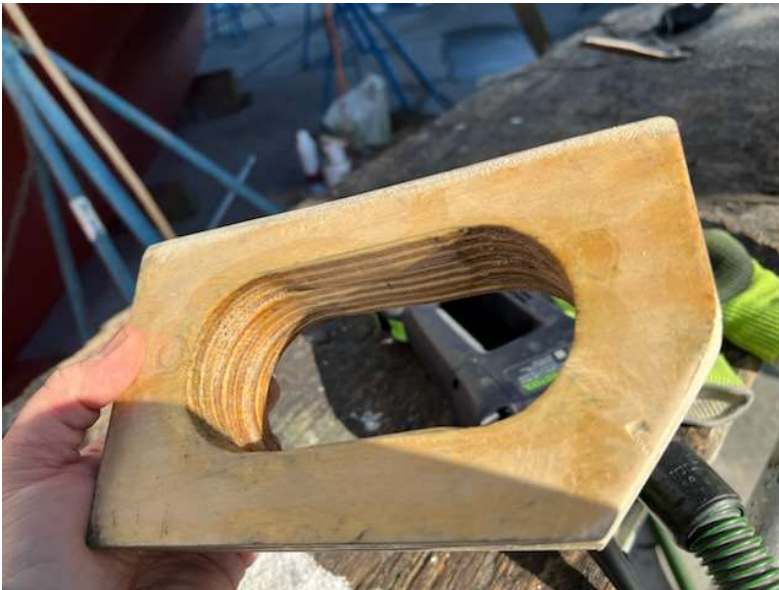
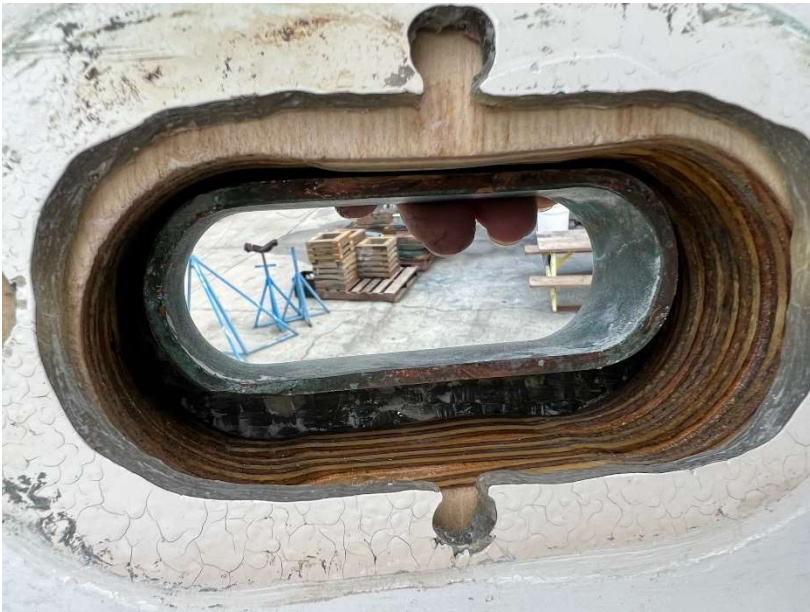
Some of the blocks needed special shapes to fit into the very tight spaces.

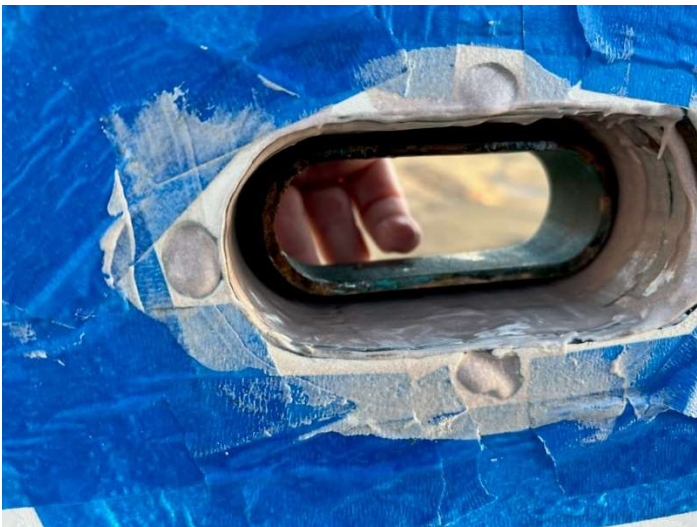
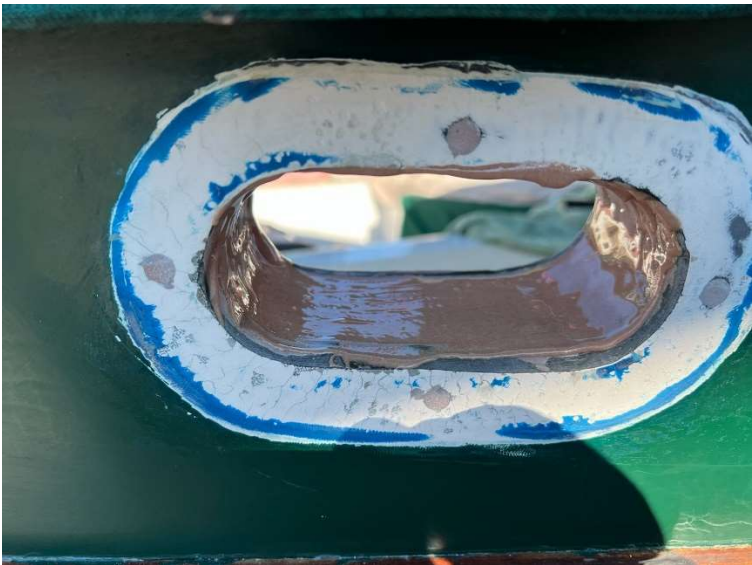
Dry fit and then epoxied into place
